Addison Road Community Centre

Conservation Management Plan

prepared for

27th July 2018

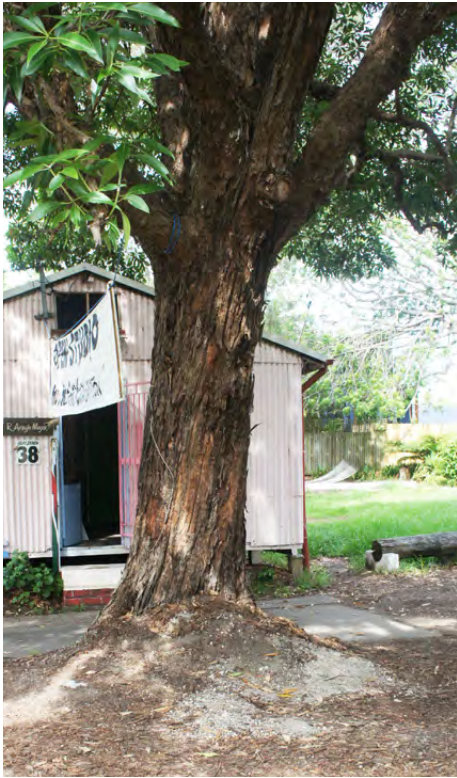
<p>Figure 3.2.31 - Queensland Brush Box next to Building 38 shows evidence of root damage</p>	<p><i>Lophostemon confertus</i> Queensland Brush Box (1 tree)</p> <p>Location: Western end of the site close to Building 38.</p> <p>Characteristic and Condition: The tree is 10-15 metres in height and canopy spread. Noted as being in good health despite evidence of root damage due to soil compaction.</p> <p>Date: c. 1920s</p>	<p>High Significance</p> <p>Tree dates from the pre-1930s Army Period. It is a substantial specimen which forms part of the entry experience and has a large canopy that shades the adjacent section of Addison Road.</p> <p>The tree its roots and canopy should be protected and maintained to retain cultural significance.</p>

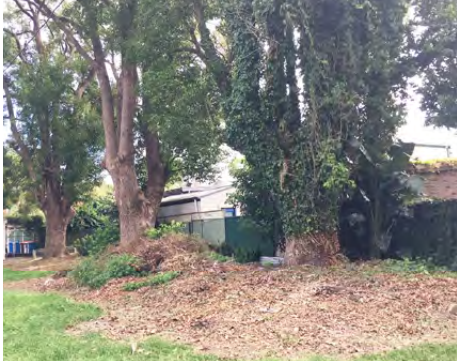
<p>Figure 3.2.34 - Soil grade changes around one tree</p>	<p><i>Cinnamomum camphora</i> Camphor Laurel (3 trees)</p> <p>Location: Close to the northern property boundary (to the rear of the grassed area between Buildings 21 and 47).</p> <p>Characteristic and Condition: Large trees are almost 30 metres in height and canopy spread. Two of the trees are in good health and one tree (located furthest from Building 21) is in poor health (noted to be likely as a consequence of soil grade changes).</p> <p>Date: c. 1930s</p>	<p>High Significance</p> <p>The three trees date from the pre-1943 army period. The trees are significant boundary plantings and should be retained and protected. If failure occurs a suitable species of similar habit and form should be considered to retain cultural significance.</p>

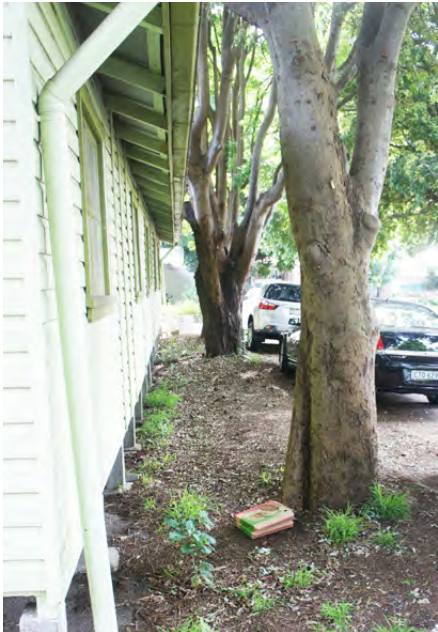
<p>Figure 3.2.43 - Cars park on tree roots next to buildings 44 and 45.</p>	<p><i>Flindersia australis</i> Crow's Ash (3 trees)</p> <p>Location: Along the western edge of the access road adjacent to Buildings 44 (Bush Music Club) and 45 (Kid A Performing Arts Co.).</p> <p>Characteristic and Condition: The trees are between 15-20 metres in height with a canopy spread 10-15 metres forming an avenue along the access road. The trees are noted as being in good health. Vehicles are currently parking on tree roots resulting in compaction and root damage.</p> <p>Date: c. 1940s</p>	<p>High Significance</p> <p>The trees are part of a significant avenue of large canopy trees of diverse species that date from the pre-1950 period.</p> <p>The avenue should be protected and maintained to retain cultural significance.</p>

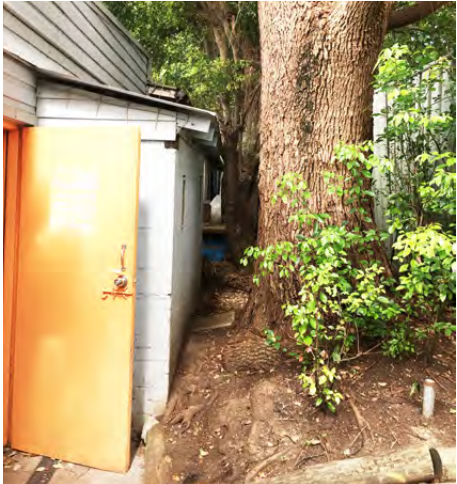
<p>Figure 3.2.45 - Camphor Laurel tree between building 24 and the boundary fence</p>	<p><i>Syzigium floribundum</i> Weeping Lilly Pilly (8 trees) <i>Cinnamomum camphora</i> Camphor Laurel (1 tree)</p> <p>Location: Along the western property boundary (behind buildings 24 and 24A).</p> <p>Characteristic and Condition: Nine mature trees approximately 15-20 metres in height with a canopy spread of 10-15 metres. The trees are noted as being in good health with one tree in fair health and one tree in poor health. All trees suffer from poor pruning. The Camphor Laurel tree at the northern of the row is also 15-20 metres in height with a canopy spread of 10-15 metres. This tree is in fair health however the root system is exposed and has become restricted by the building.</p> <p>Date: c. 1940s</p>	<p>Moderate Significance</p> <p>This grouping dates from the pre-1950s period and are mature specimens. The trees are confined between the boundary and Drill Hall 2.</p> <p>The Camphor laurel has a significant canopy which has a strong presence on the boundary. However, the rootball of the Camphor laurel is pressing on the wall of this building and the tree may need to be removed to reduce the impact of the tree on the building. If removed the tree should not be replaced.</p> <p>The Weeping Lilly Pilly trees should be protected but the tree roots should be monitored to ensure there is no damage to the Drill Hall building.</p>

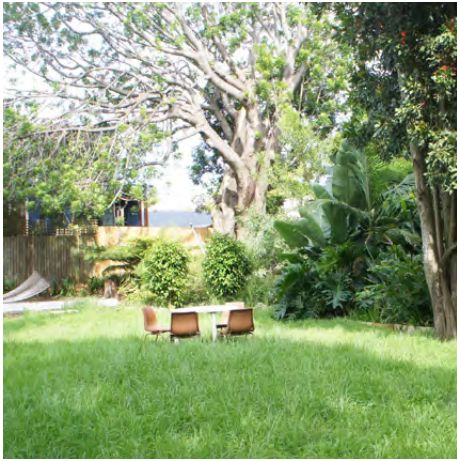
<p>Figure 3.2.46 - Kaffir Plum trees - One large tree and one tree stump</p>	<p><i>Harpephyllum caffrum</i> Kaffir Plum (2 trees)</p> <p>Location: Against the boundary in the south western corner of the site.</p> <p>Characteristic and Condition: One very large mature tree and one large stump. The living tree has a very large spread of 20-30 metres and is noted as being in good health. The large stump has been cut to around 3 metres.</p> <p>Date: c.1940s</p>	<p>High Significance</p> <p>Visible on the 1950 aerial the remaining Kaffir Plum is a landmark boundary planting and should be protected and maintained to retain cultural significance. The stump of the second tree has no significance and can be removed or replaced.</p>

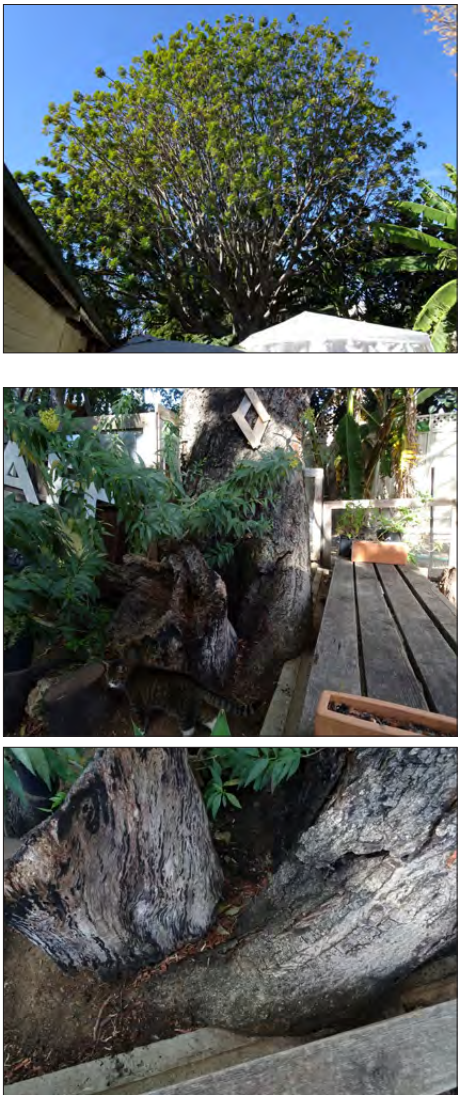
<p>Figure 3.2.56 - Kaffir Plum tree at the rear of Building 35.</p>	<p><i>Harpephyllum caffrum</i> Kaffir Plum (1 tree)</p> <p>Location: At the boundary fence in the cafe courtyard (at the rear of Building 35).</p> <p>Characteristic and Condition: The large tree has a 20 metre canopy spread and is in good health.</p> <p>Date: c.1991-2002</p>	<p>Moderate Significance</p> <p>The tree should be maintained and protected, as it is a large specimen on the boundary.</p> <p>However, if tree roots become an issue for the neighbouring property, the tree should be pruned, or consideration given to removal if required.</p>

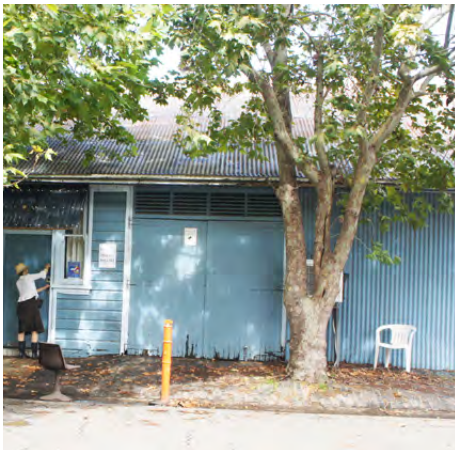
<p>Figure 3.2.59 - Two London Plane trees at the front Building 36</p>	<p><i>Platanus x hybrida</i> London Plane (2 trees)</p> <p>Location: Two mature London Plane trees flank the front entrance of Building 36.</p> <p>Characteristic and Condition: The trees have an average 15 metres height and spread and are in good health.</p> <p>Associated with Greek village squares, Olive and Lemon Trees were also planted outside this building by members of the Greek Cultural Association (refer Fig. 2.62)- one lemon tree remains (Castrique, OSW, pp 69 and 72)</p> <p>Date: c.1990</p>	<p>Moderate Significance</p> <p>This tree should be maintained and protected to retain cultural significance.</p> <p>If the trees fail they could be considered for replacement by the same or different species but further from the building in another location.</p>

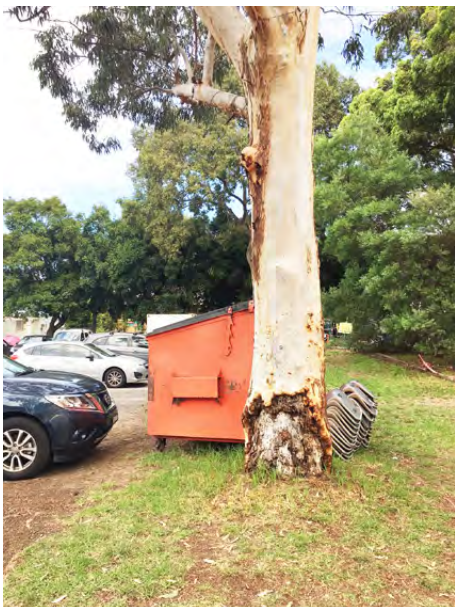
<p>Figure 3.2.65 - Bins and other materials stored around the base of the Sydney Blue Gum</p>	<p><i>Eucalyptus Saligna</i> Sydney Blue Gum (1 tree)</p> <p><i>Corymbia maculata</i> Spotted Gum (1 tree)</p> <p>Location: Two trees planted in a grassed area at the edge of the main car park.</p> <p>Characteristic and Condition: Two tall mature native trees 15-20 metres in height and have a 10-15 metre canopy spread. The trees are noted as being in good health. There are large bins and other materials stored around the base of the Sydney Blue Gum.</p> <p>Date: c. mid 1990s</p>	<p>Moderate Significance</p> <p>This tree group should be maintained and protected to retain cultural significance.</p> <p>If the trees fail they could be considered for replacement by the same species or similar to maintain the overall tree canopy.</p>

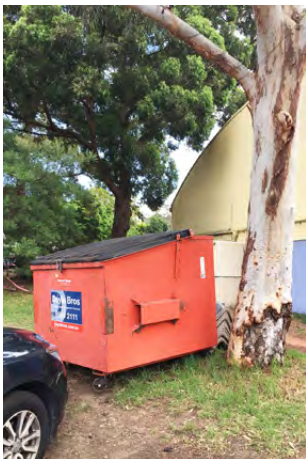
<p>Figure 3.2.88 - Large waste bin on the western side of car park</p>	<p>Bins</p> <p>Location: A collection of 240L plastic bins (waste and recycling) are stored outside the Ethnic Community Services Co-operative. Three 1000L waste bins are positioned on the southern elevation of Building 5. A large waste bin (approximately 8m3) is located on the western edge of the car park, sited against a mature Sydney Blue Gum tree.</p> <p>Characteristic and Condition: All bins are on wheels and moveable. There are no fixed litter bins on site.</p>	<p>Intrusive</p> <p>Bins at ARCC are found throughout the site sometimes clearly visible in major view corridors.</p> <p>Ideally bins should be placed and concealed where views are least affected to maintain cultural significance and minimise risk of illegal dumping.</p>
