Addison Road Community Centre

Conservation Management Plan

prepared for

27th July 2018

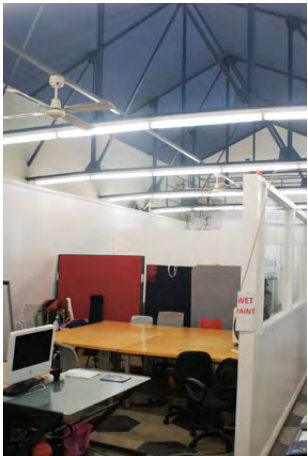
<p>Figure 3.4 - Interior showing original steel trusses</p> <p>Photos: Phillips Marler 2017</p>	<p>Gun Park c. 1914-16 ARCCO Main Office</p> <p>Location: Southern side of the site facing the main car park.</p> <p>Condition and Characteristics:</p> <p>Overall condition: Fair</p> <p>Roof: Corrugated steel Roof structure: Steel trusses and timber framing Floor: Concrete Walls: Weatherboard cladding on timber frame Ceiling: Timber lining boards and plasterboard</p> <p>One of the original WW1 Gun Parks, this building has been substantially altered since its construction. Originally the building was longer and has been shortened by demolition of the south-eastern end.</p> <p>The original corrugated roof sheeting has been replaced with newer corrugated cladding.</p> <p>The exterior walls have been altered with the infill of original garage door openings, the insertion of new windows and doors and new weatherboard cladding. Some original weatherboard cladding remains.</p> <p>The original timber floors (to harness rooms and offices) and original timber baulk floor (to gun parking / garage space) have all been replaced by concrete floors.</p> <p>Internally most of the original timber lining boards to the ceiling have been replaced by plasterboard. Some original internal timber lining boards remain.</p> <p>The building has been fitted out with modern plasterboard partitions. The original clear-spanning, riveted steel roof trusses remain.</p> <p>The original single storey, gable roof form of the building remains.</p>	<p>Overall external building form: High significance Steel roof trusses and timber framing: High significance Timber ceiling boards: High significance Original external weatherboard cladding: High significance Roof cladding: Moderate significance Non-original weatherboard cladding: Moderate significance Concrete Floor: Little significance Internal fit-out walls: Little significance</p> <p>Recommendation: As one of the original Gun Parks and part of the 'World War One Group' of buildings, the overall building form, the steel trusses, the internal timber ceiling boards and the original external weatherboards should be conserved and maintained to retain cultural significance.</p> <p>The external elevations have been significantly altered. It is not practicable to restore the external elevations to their original appearance by reconstructing the garage doors because of ongoing new uses and functions of the building. Nor is it practicable to demolish the current concrete floor and reconstruct the timber floors.</p> <p>The building could be extended in an easterly direction, in line with its historic footprint, and still maintain cultural significance.</p>

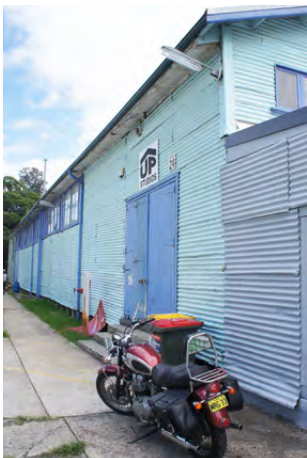
<p>Figure 3.15 - Eastern elevation</p>

<p>Figure 3.17 - Southern elevation</p> <p>Photos: Phillips Marler 2017</p>	<p>Drill Hall No.2 c.1916 Ultimo Project (24) and Art Resistance (24a)</p> <p>Location: Along the western side of the site behind buildings 39-43.</p> <p>Characteristic and Condition:</p> <p>Overall condition: Fair</p> <p>Roof: Corrugated steel Rolled roof ridge ventilator: Corrugated steel Roof structure: Steel trusses and timber framing Floor: Timber boards Walls: Corrugated steel cladding on timber frame Walls and ceilings to skillion roof section: Timber lining boards Windows: Timber</p> <p>Originally Drill Hall No. 2, this building has remained substantially intact since its construction.</p> <p>The corrugated steel roof sheeting is probably original. The original clear-spanning, riveted steel roof trusses remain, as does the timber roof framing.</p> <p>The original timber floor remains</p> <p>The corrugated steel cladding to the walls is original.</p> <p>The timber lining boards to the walls and ceilings to the skillion roof section are original.</p> <p>The timber windows are original. The original single storey, gable roof form and rolled ridge ventilator of the building is intact.</p>	<p>Building: Outstanding significance</p> <p>Corrugated steel roof: High significance Rolled roof ridge ventilator: High significance Steel roof trusses and timber framing: High significance Timber floor: High significance Corrugated steel wall cladding on timber frame: High significance Timber boarded walls and ceilings to skillion roof section: High significance Timber windows: High significance</p> <p>Non-original fitout walls and joinery: Little significance</p> <p>Recommendation: As one of the 'World War One Group' of buildings, and probably the second substantial building to be constructed on site, Drill Hall No. 2 should be conserved, restored and maintained to retain cultural significance.</p>

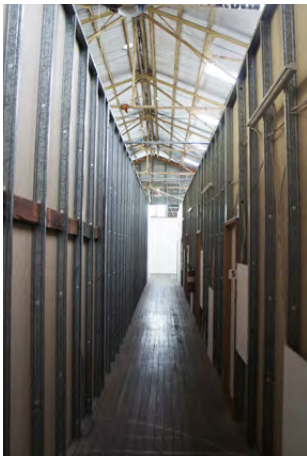
<p>Figure 3.16 - Interior (building 24)</p>

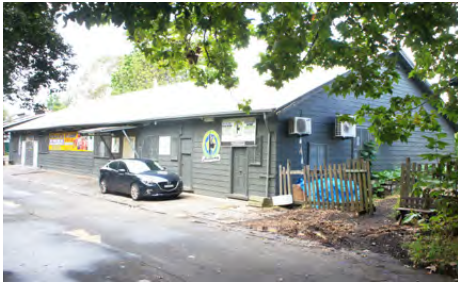
<p>Figure 3.18 - Northern elevation (western end)</p>

<p>Figure 3.20 - Interior</p> <p>Photos: Phillips Marler 2017</p>	<p>Gun Park No.3 c.1914-1916 Australian Martial Arts Academy</p> <p>Location: Along the southern boundary of the site facing the large open green space.</p> <p>Characteristic and Condition:</p> <p>Overall Condition: Fair</p> <p>Roof: Corrugated steel Roof structure: Steel trusses and timber framing (assumed) Floor: Concrete Walls: Fibre cement weatherboards Ceiling: Plasterboard</p> <p>One of the original WW1 Gun Parks, this building has been substantially altered since its construction.</p> <p>The original corrugated roof sheeting has been replaced by newer corrugated sheeting. The original ventilation cowls on the ridge remain.</p> <p>The exterior walls have been altered with the infill of the original garage door openings, the insertion of new windows and doors and the replacement of original timber weatherboards with fibre cement weatherboards.</p> <p>The original timber floors (to what were harness rooms and offices) and the original timber baulk floor (to the gun parking/garage space) have all been replaced by a concrete floor.</p> <p>Internally, a new flat plasterboard ceiling has been installed, concealing the original steel roof trusses and timber framing.</p> <p>Some original timber windows remain.</p> <p>The original single storey, gable roof form of the building remains.</p>	<p>Building: High significance</p> <p>Overall external building form: High significance Steel roof trusses and timber roof framing: High significance Original timber windows: High significance Non-original plasterboard ceiling: Little significance Roof cladding: Moderate significance Non-original FC weatherboard cladding: Little significance Concrete Floor: Little Significance Internal fit-out walls: Little significance</p> <p>Recommendation: As one of the original Gun Parks and part of the 'World War One Group' of buildings, the overall building form, the steel trusses and the original timber windows should be conserved and maintained to retain cultural significance.</p> <p>The external elevations have been significantly altered. It is not practicable to restore the external elevations to their original appearance by reconstructing the garage doors because of ongoing new uses and functions of the building. Nor is it practicable to demolish the current concrete floor and reconstruct the timber floors.</p>

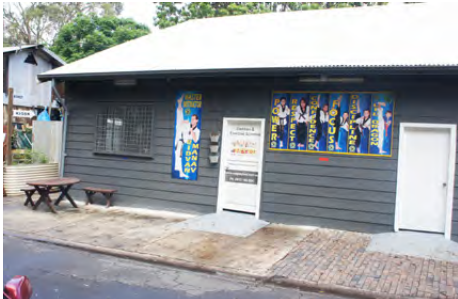
<p>Figure 3.19 - Northern elevation (eastern end)</p>

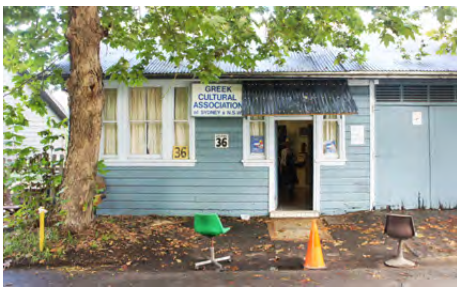
<p>Figure 3.21 - Northern elevation (eastern end)</p>

<p>Figure 3.23 - Interior</p> <p>Photos: Phillips Marler 2017</p>	<p>Gun Park No.4 c.1914-1916 Greek Cultural Association (Hellenic Art Theatre)</p> <p>Location: Along the southern boundary of the site facing the large open green space.</p> <p>Characteristic and Condition:</p> <p>Overall Condition: Fair</p> <p>Roof: Corrugated steel Roof structure: Steel trusses and timber framing Floor: Possibly original timber floor and timber baulks under ply floor lining Walls: Weatherboard cladding on timber frame Ceiling: Timber lining boards and sheeting lining materials</p> <p>One of the original WW1 Gun Parks, this building has been moderately altered since its construction. Of the remaining three Gun Parks, this building has the most remaining original fabric.</p> <p>The original corrugated roof sheeting has been replaced by newer corrugated sheeting. The original ventilation cowls on the ridge remain.</p> <p>The north elevation has been substantially altered with the infill of most the original garage door openings with vertical corrugated steel sheeting. However, two pairs of original garage doors remain.</p> <p>On the other elevations most of the original weatherboards and timber windows remain.</p> <p>The original timber floors (to what were harness rooms and offices) and the original timber baulk floor (to the gun parking/garage space) are possibly still underneath ply floor lining.</p> <p>Original timber ceiling lining boards remain over what were the former offices and harness rooms.</p>	<p>Over the main theatre space (formerly gun parking/garage space), the original timber lining boards have been removed.</p> <p>The original clear-spanning, rivetted steel roof trusses remain.</p> <p>The original single storey, gable roof form of the building remains.</p> <p>Building: High significance</p> <p>Overall external building form: High significance Steel roof trusses and timber roof framing: High significance Roof cladding: Moderate significance Original timber windows: High significance Original garage doors: High significance Original external weatherboard cladding: High significance Non-original external vertical steel cladding: Little significance Non-original ply or plasterboard ceiling: Little significance Internal fit-out walls: Little significance Possible original timber floors/timber baulks under ply sheet lining: High significance</p> <p>Recommendation: As one of the original Gun Parks and part of the 'World War One Group' of buildings, the overall building form, the steel trusses, the timber weatherboards, garage doors, other original elements and the original timber floors (if still extant) should be conserved and maintained to retain cultural significance.</p> <p>The external elevations have been moderately altered. It is not practicable to restore the external north elevation to its original appearance by reconstructing the missing garage doors because of ongoing new uses and functions of the building.</p>

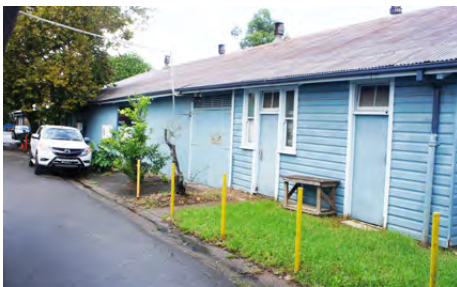
<p>Figure 3.22 - Northern elevation (western end)</p>

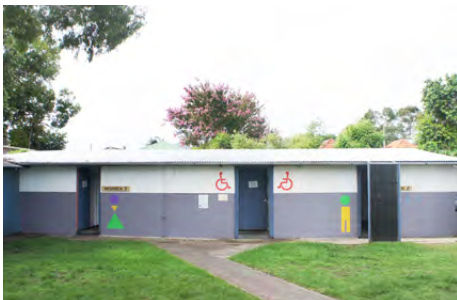
<p>Figure 3.24 - North western elevation Photo: Phillips Marler 2017</p>

<p>Figure 3.25 - Plumbing Diagram for toilets, part of Specification for Two Drill Halls. 1914 Source: National Archives of Australia, SP155-NSW 3135 MILITARY</p>	<p>Latrine c.1914 Toilet Block</p> <p>Location: Eastern end of the site next to Building 9b (Depot Theatre)</p> <p>Characteristic and Condition:</p> <p>Overall condition: Fair</p> <p>Roof: Corrugated steel Floor: Concrete Walls: Concrete block and corrugated steel on timber frame Ceiling: Sheet material (possibly asbestos) and battens</p> <p>This building was probably the first toilet block constructed on the site, at the same time as Drill Hall No. 1. A drawing, possibly of this building, appears in the 1914 specification for Drill Hall No. 1 (refer Fig. 3.25).</p> <p>The building has been substantially altered since its construction. Some of the original timber boarded internal toilet partitions and some external corrugated steel walls remain.</p>	<p>Building: Moderate significance</p> <p>Recommendation: The building can be maintained as toilets and renovated as required. If renovation is not financially or functionally feasible, the building can be demolished without affecting the cultural significance of the overall site.</p>

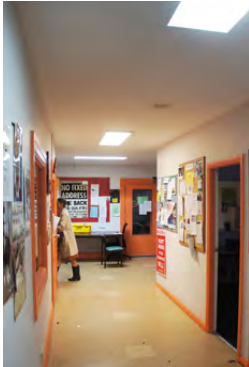
<p>Figure 3.31 - Interior Photos: Phillips Marler 2017</p>

<p>Figure 3.33 - Camp cooks on the job at the camp cookers or Soyer boilers or stoves Source: Army field kitchens in Australia, WWII, Argus Collection of Photographs, State Library of Victoria, 1976</p>	<p>Kitchen and 'Soyer' Stove Area c. 1940 Radio Skid Row</p> <p>Location: North western corner of the site next to Building 24</p> <p>Characteristic and Condition</p> <p>Overall condition: Fair</p> <p>Roof: Corrugated steel Roof structure: Timber Floor: Timber boards on timber framing on stumps Walls: Corrugated steel cladding on timber framing Ceilings: Plasterboard</p> <p>This addition to the northern end of Drill Hall No. 2 was probably constructed in the 1940s, first appearing on a 1941 site plan (refer Fig. 3.32) The building originally consisted of kitchen on the west side and a 'Soyer Area' on the east side.</p> <p>The Soyer Stove was a field stove invented by the celebrated French Chef Alexis Benoit Soyer at the time of the Crimean War, variants of which were used by the British Army up into the 1980's. The stove was adopted by the Australian and Canadian Armies and used in World War I and World War II (refer Fig. 3.33).</p> <p>The building has been extended and significantly altered since the 1940s. The interiors have been significantly altered.</p>	<p>Building: Moderate significance</p> <p>Overall external building form: Moderate significance</p> <p>Recommendation: This building is one of the Second World War group of buildings and constitutes a minor servicing addition to Drill Hall No. 2. The building should be kept and maintained.</p> <p>It can be internally altered as needed for future functional use without affecting the cultural significance either of itself or the adjoining Drill Hall No. 2.</p> <p>New openings can be made in the external walls as needed for future functional use.</p> <p>The external cladding should be kept as corrugated steel.</p>

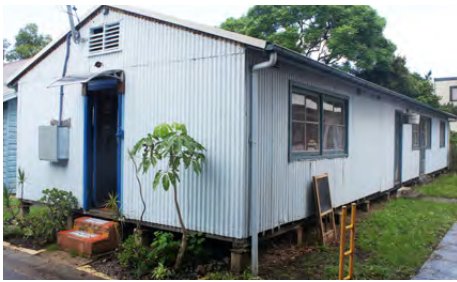
<p>Figure 3.34 - Northern elevation</p>

<p>Figure 3.35 - The WW2 Sleeping Hut Group, SH2, SH3, SH4, SH5, SH6, SH7 Detail from Marikville Military Depot Block Plan 1941 Source: National Archives of Australia, ST3294/1ST3294/1/0456/7/746</p>	<p>Sleeping Hut 7 c. 1940 Arts Studios/Drawn to Seeing</p> <p>Location: South western corner of the site, (opposite Building 39).</p> <p>Characteristic and Condition:</p> <p>Overall condition: Fair</p> <p>Roof: Corrugated steel on timber frame Floor: Timber on concrete piers Walls: Corrugated steel on timber frame Internal wall linings: Masonite and timber Ceiling: Masonite</p> <p>This building is part of the World War II Sleeping Hut group that first appear on a 1941 site plan, described as 'SH 2' to 'SH7' (refer Fig. 3.35).</p> <p>Building No. 37 is referred to as 'SH7', Sleeping Hut 7.</p> <p>The building is in largely original condition. The original asbestos roof sheeting has been replaced with corrugated steel.</p>	<p>Building: High significance</p> <p>Overall external building form: High significance Overall building interior: Moderate significance Roof cladding: Moderate significance Original external corrugated steel wall cladding: High significance Original internal partitions: Moderate significance Original masonite internal lining: Moderate significance Original timber floor: High significance Original timber windows: High significance</p> <p>Recommendation: As one of the Second World War group of buildings, the overall building form, the original corrugated steel wall cladding, timber windows and timber floors should be conserved and maintained to retain cultural significance.</p> <p>The interior is ranked of lesser significance than the exterior. Internal alterations such as moving or removal of existing partitions, new joinery and installation of new services can be carried out without reducing cultural significance.</p>

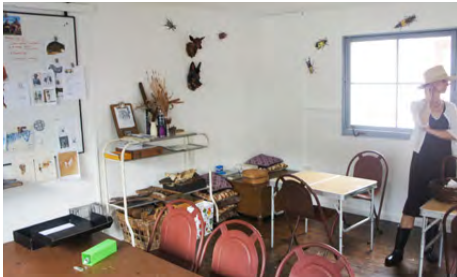
<p>Figure 3.35 - Interior Photos: Phillips Marler 2017</p>

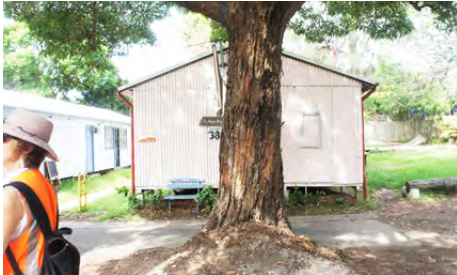
<p>Figure 3.36 - Northern elevation</p>

<p>Figure 3.38 - Interior, with Carlos Temenias of El Taller Studios.</p> <p>Photos: Phillips Marler 2017</p>	<p>Sleeping Hut 6 c. 1940 El Taller Art Studios</p> <p>Location: South western corner of the site, (next to Building 37).</p> <p>Characteristic and Condition:</p> <p>Overall condition: Fair</p> <p>Roof: Corrugated steel on timber frame Floor: Timber on concrete piers Walls: Corrugated steel on timber frame Internal wall linings: Masonite Ceiling: Masonite</p> <p>This building is part of the Second World War Sleeping Hut group that first appear on a 1941 site plan, described as 'SH 2' to 'SH7' (refer Fig. 3.35).</p> <p>This building is described as 'SH 6', Sleeping Hut 6.</p> <p>The building is in largely original condition. The original asbestos roof sheeting has been replaced with corrugated steel.</p>	<p>Building: High significance</p> <p>Building: High significance Overall external building form: High significance Overall building interior: Moderate significance Roof cladding: Moderate significance Original external corrugated steel wall cladding: High significance Original internal partitions: Moderate significance Original masonite internal lining: Moderate significance Original timber floor: High significance Original timber windows: High significance</p> <p>Recommendation: As one of the Second World War group of buildings, the overall building form, the original corrugated steel wall cladding, timber windows and timber floors should be conserved and maintained to retain cultural significance.</p> <p>The interior is ranked of lesser significance than the exterior. Internal alterations such as moving or removal of existing partitions, new joinery and installation of new services can be carried out without reducing cultural significance.</p>

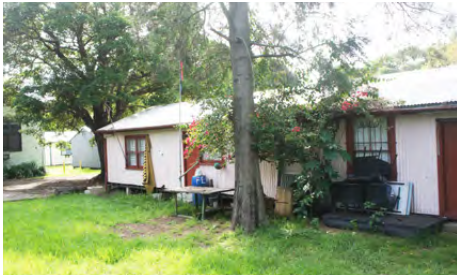
<p>Figure 3.37 - Western elevation</p>

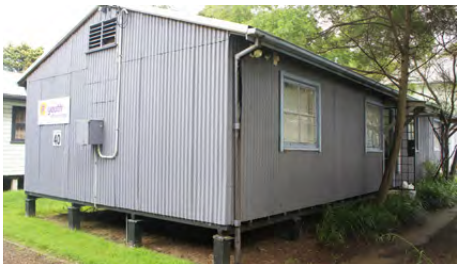
<p>Figure 3.39 - Northern and eastern elevation</p>

<p>Figure 3.40 - Interior</p> <p>Photos: Phillips Marler 2017</p>	<p>Sleeping Hut 5 Youth Off The Streets/ Louise Cox</p> <p>Location: South western corner of the site, (opposite Building 39).</p> <p>Characteristic and Condition:</p> <p>Overall condition: Fair</p> <p>Roof: Corrugated steel on timber frame Floor: Timber on concrete piers Walls: Corrugated steel on timber frame Internal wall linings: Masonite Ceiling: Masonite</p> <p>This building is part of the Second World War Sleeping Hut group that first appear on a 1941 site plan, described as 'SH 2' to 'SH7' (refer Fig. 3.35).</p> <p>This building is described as 'SH 5', Sleeping Hut 5.</p> <p>The building is in largely original condition. The original asbestos roof sheeting has been replaced with corrugated steel.</p>	<p>Building: High significance</p> <p>Overall external building form: High significance Overall building interior: Moderate significance Roof cladding: Moderate significance Original external corrugated steel wall cladding: High significance Original internal partitions: Moderate significance Original masonite internal lining: Moderate significance Original timber floor: High significance Original timber windows: High significance</p> <p>Recommendation: As one of the Second World War group of buildings, the overall building form, the original corrugated steel wall cladding, timber windows and timber floors should be conserved and maintained to retain cultural significance.</p> <p>The interior is ranked of lesser significance than the exterior. Internal alterations such as moving or removal of existing partitions, new joinery and installation of new services can be carried out without reducing cultural significance.</p>

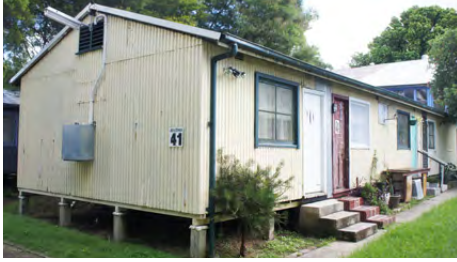
<p>Figure 3.41 - Eastern and northern elevation</p>

<p>Figure 3.42 - Interior of one of the four studios in the building.</p> <p>Photos: Phillips Marler 2017</p>	<p>Sleeping Hut 4 Murmuration/ Anita Shirley/ Berli/ Fruit Salad Kids</p> <p>Location: Western end of the site (behind Building 45).</p> <p>Characteristic and Condition:</p> <p>Overall condition: Fair</p> <p>Roof: Corrugated steel on timber frame Floor: Timber on concrete piers Walls: Corrugated steel on timber frame Internal wall linings: Masonite Ceiling: Masonite</p> <p>This building is part of the Second World War Sleeping Hut group that first appear on a 1941 site plan, described as 'SH 2' to 'SH7' (refer Fig 3.35).</p> <p>This building is described as 'SH 4', Sleeping Hut 4.</p> <p>The building is in largely original condition. The original asbestos roof sheeting has been replaced with corrugated steel.</p>	<p>Building: High significance</p> <p>Overall external building form: High significance Overall building interior: Moderate significance Roof cladding: Moderate significance Original external corrugated steel wall cladding: High significance Original internal partitions: Moderate significance Original masonite internal lining: Moderate significance Original timber floor: High significance Original timber windows: High significance</p> <p>Recommendation: As one of the Second World War group of buildings, the overall building form, the original corrugated steel wall cladding, timber windows and timber floors should be conserved and maintained to retain cultural significance.</p> <p>The interior is ranked of lesser significance than the exterior. Internal alterations such as moving or removal of existing partitions, new joinery and installation of new services can be carried out without reducing cultural significance.</p>

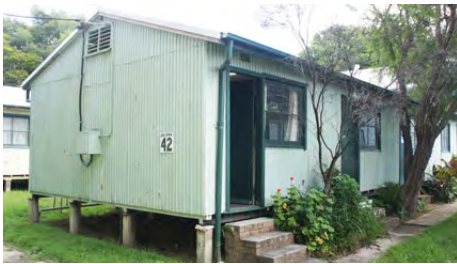
<p>Figure 3.43 - Northern elevation</p>

<p>Figure 3.45 - WW2 Sleeping Huts adjacent Drill Hall No. 2. SH3 and SH2 are Transit Officers Quarters. Detail from Marrickville Military Depot Block Plan 1941 Source: National Archives of Australia, ST3294/1ST3294/1/0456/7/746</p>	<p>Sleeping Hut 3 and Transit Officers Quarters c. 1940 Studios</p> <p>Location: Western end of the site (behind Building 44).</p> <p>Characteristic and Condition:</p> <p>Overall condition: Fair</p> <p>Roof: Corrugated steel on timber frame Floor: Timber on concrete piers Walls: Corrugated steel on timber frame Internal wall linings: Masonite Ceiling: Masonite</p> <p>This building is part of the Second World War Sleeping Hut group that first appear on a 1941 site plan, described as 'SH 2' to 'SH7' (refer Fig. 3.35).</p> <p>This building is described as 'SH 3', Sleeping Hut 3, and 'Transit Officers Quarters'. 'Batman' quarters are located at one end (refer to Fig. 3.45).</p> <p>The building is in largely original condition. The original asbestos roof sheeting has been replaced with corrugated steel.</p>	<p>Building: High significance</p> <p>Overall external building form: High significance Overall building interior: Moderate significance Roof cladding: Moderate significance Original external corrugated steel wall cladding: High significance Original internal partitions: Moderate significance Original masonite internal lining: Moderate significance Original timber floor: High significance Original timber windows: High significance</p> <p>Recommendation: As one of the Second World War group of buildings, the overall building form, the original steel corrugated wall cladding, timber windows and timber floors should be conserved and maintained to retain cultural significance.</p> <p>The interior is ranked of lesser significance than the exterior. Internal alterations such as moving or removal of existing partitions, new joinery and installation of new services can be carried out without reducing cultural significance.</p>

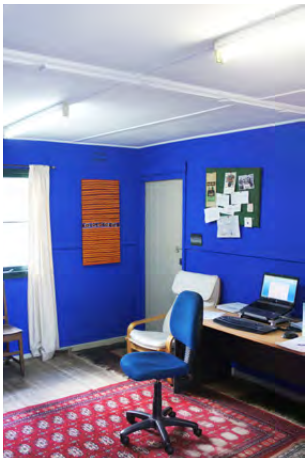
<p>Figure 3.44 - Interior Photos: Phillips Marler 2017</p>

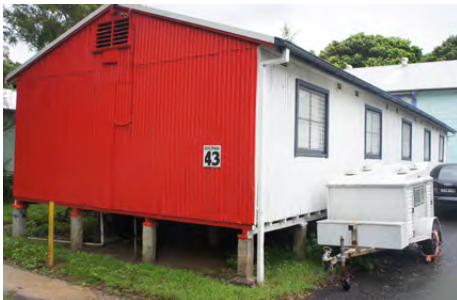
<p>Figure 3.46 - Eastern and northern elevation</p>

<p>Figure 3.47 - Interior</p> <p>Photos: Phillips Marler 2017</p>	<p>Sleeping Hut 2 and Transit Officers Quarters c. 1940 Maggies Rescue</p> <p>Location: Western end of the site (behind Building 44)</p> <p>Characteristic and Condition</p> <p>Overall condition: Fair</p> <p>Roof: Corrugated steel on timber frame Floor: Timber on concrete piers Walls: Corrugated steel on timber frame Internal wall linings: Masonite Ceiling: Masonite</p> <p>This building is part of the World War Sleeping Hut group that first appear on a 1941 site plan, described as 'SH 2' to 'SH7' (refer Fig. 3.35).</p> <p>This building is described as 'SH 2', Sleeping Hut 2, and 'Transit Officers Quarters' (refer Fig. 3.44).</p> <p>The building is in largely original condition. The original asbestos roof sheeting has been replaced with corrugated steel.</p>	<p>Building: High significance</p> <p>Overall external building form: High significance Overall building interior: Moderate significance Roof cladding: Moderate significance Original external corrugated steel wall cladding: High significance Original internal partitions: Moderate significance Original masonite internal lining: Moderate significance Original timber floor: High significance Original timber windows: High significance</p> <p>Recommendation: As one of the Second World War group of buildings, the overall building form, the original steel corrugated wall cladding, timber windows and timber floors should be conserved and maintained to retain cultural significance.</p> <p>The interior is ranked of lesser significance than the exterior. Internal alterations such as moving or removal of existing partitions, new joinery and installation of new services can be carried out without reducing cultural significance.</p>

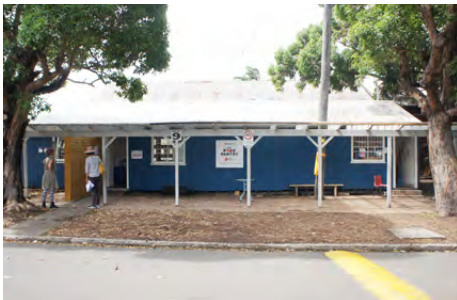
<p>Figure 3.48 - North-Western elevation</p>

<p>Figure 3.50 - Northern elevation</p> <p>Photos: Phillips Marler 2017</p>	<p>Regimental Aid Post c.1940 Youth off the Streets/ ARCCO Food Pantry</p> <p>Location: Eastern side of the site near the start of Vivi Koutsounadis Drive.</p> <p>Characteristic and Condition:</p> <p>Overall condition: Fair</p> <p>Roof: Corrugated steel on timber frame Floor: Timber, possibly framing on ground Walls: Corrugated steel on timber frame Internal wall linings: Masonite Ceiling: Masonite</p> <p>This building first appears on a 1941 site plan, described as 'RAP', probably 'Regimental Aid Post'.</p> <p>The building is in largely original condition. The original asbestos roof sheeting has been replaced with corrugated steel.</p>	<p>Building: High significance</p> <p>Overall external building form: High significance Overall building interior: Moderate significance Roof cladding: Moderate significance Original external corrugated steel wall cladding: High significance Exposed internal timber roof framing: High significance Original internal partitions: Moderate significance Original masonite internal lining: Moderate significance Original timber floor: High significance Original timber windows: High significance</p> <p>Recommendation: As one of the Second World War group of buildings, the overall building form, the original corrugated steel wall cladding, exposed internal timber roof framing, timber windows and timber floors should be conserved and maintained to retain cultural significance.</p> <p>The interior, apart from the exposed internal timber roof framing, is ranked of lesser significance than the exterior. Internal alterations such as moving or removal of existing partitions, new joinery and installation of new services can be carried out without reducing cultural significance.</p>

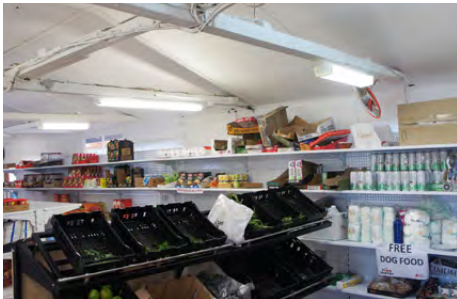
<p>Figure 3.49 - Interior</p>

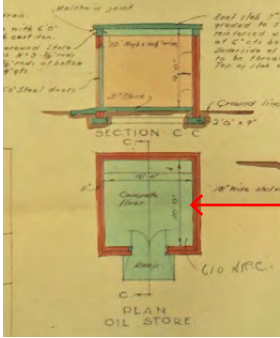
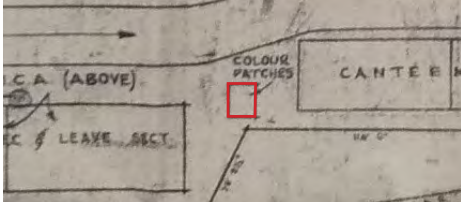
<p>Figure 3.52C - PTO Detail from Marrickville Military Depot Block Plan 1941-1946</p> <p>Source: National Archives of Australia, ST3294/0456/7/746</p>	<p>Building Oil Store c. 1939, Colour Patches Store c.1941</p> <p>Brick Storage</p> <p>Location: Northern side of the site (between Building 13 and Building 15).</p> <p>Characteristic and Condition:</p> <p>Overall condition: Fair</p> <p>Roof: Concrete, with steel-roofed front awning. Floor: Concrete Walls: Brick</p> <p>This simple little building was constructed around 1939 as an Oil Store in conjunction with a new Motor Transport Garages building, since demolished (refer Figs 3.52A and 3.52B).</p> <p>By 1941 the building is referred to, and presumably used for the storage of, 'Colour Patches' (refer Fig. 3.52c).</p> <p>Beginning in 1915, colour patches were worn on the sleeve of every Australian soldier and identified the Division, Brigade and Battalion to which the soldier belonged. Today colour patches are worn on the slouch hat.</p> <p>The building is in largely original condition.</p>	<p>Building: Moderate significance</p> <p>Overall external building form: Moderate significance</p> <p>Overall building interior: Moderate significance</p> <p>Recommendation: As one of the Second World War group of buildings and as an example of a minor army service building, this building should be conserved and maintained to retain cultural significance.</p>

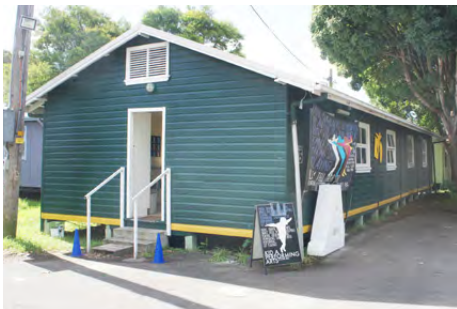
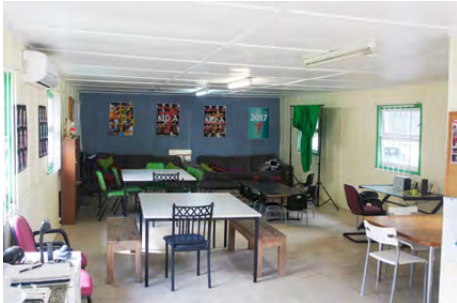
Building No.	Photograph	Description and Condition	Significance Rating and Recommendation
45

<p>Figure 3.59 - Interior</p>	<p>Other Ranks Accommodation Hut c. 1949 Kid A Performing Arts Co.</p> <p>Location: Western end of the site facing the large green open space area</p> <p>Characteristic and Condition:</p> <p>Overall condition: Fair</p> <p>Roof: Corrugated steel on timber frame Floor: Timber on concrete piers Walls: Timber weatherboards Internal wall linings: Masonite and timber Ceiling: Masonite</p> <p>This building is one of three huts (Buildings 39, 44, 45) that were transported to Marrickville from the North Strathfield 2nd Army Trades Training Depot in 1949. These buildings are very similar to the Second War Sleeping Hut group but are distinguished by having timber weatherboard cladding rather than the corrugated steel cladding of the WWII group. Although these buildings are described as 'post war' for the Marrickville site, they were probably originally constructed during the war.</p> <p>The building is described as 'ORs' or 'Other Ranks' (other than Officers) on a 1949 site plan.</p> <p>The building is in largely original condition. The original asbestos roof sheeting has been replaced with corrugated steel.</p>	<p>Building: High significance</p> <p>Overall external building form: High significance Overall building interior: Moderate significance Roof cladding: Moderate significance Original weatherboard cladding: High significance Original internal partitions: Moderate significance Original masonite internal lining: Moderate significance Original timber wall lining: High significance Original timber floor: High significance Original timber windows: High significance</p> <p>Recommendation: As one of three immediate post-war army buildings transported from Strathfield to Marrickville, the overall building form, the original weatherboard cladding, timber windows and timber floors should be conserved and maintained to retain cultural significance. The interior is ranked of lesser significance than the exterior. Internal alterations such as moving or removal of existing partitions, new joinery and installation of new services can be carried out without reducing cultural significance.</p>

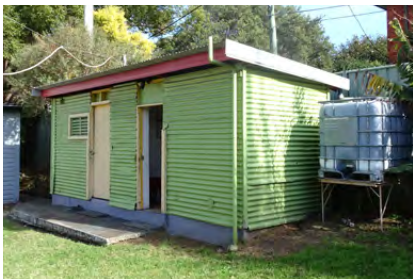
<p>Figure 3.60 - Western elevation</p>   <p>Figure 3.61 - Interior</p> <p>Photos: Phillips Marler 2017</p>	<p>Latrine and Ablution Block c 1949</p> <p>Toilet Block</p> <p>Location: Western end of the site next to Building 9.</p> <p>Characteristic and Condition:</p> <p>Overall condition: Fair</p> <p>Roof: Corrugated steel on timber frame Floor: Concrete Walls: Corrugated steel Internal wall linings: Fibre cement or plasterboard</p> <p>This building first appears on a 1949 site plan. The interior has been substantially altered since its construction. The external corrugated steel wall cladding is possibly original.</p>	<p>Building: Moderate significance</p> <p>Recommendation: The building can be maintained as toilets and renovated. Alternatively, if renovation is not financially or functionally feasible, the building can be demolished without affecting the cultural significance of the overall site.</p>

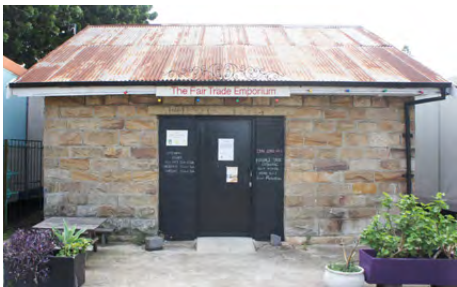
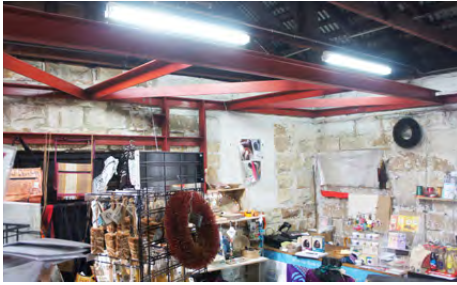
Building No.	Photograph	Description and Condition	Significance Rating and Recommendation
F

<p>Figure 3.63 - Interior</p> <p>Photos: Phillips Marler 2017</p>	<p>Armoury c. 1957 The Fair Trade Emporium</p> <p>Location: Northern edge of the site between Building 15 and Building 16 (facing the main car park).</p> <p>Characteristic and Condition:</p> <p>Overall condition: Fair</p> <p>Roof: Corrugated steel on timber frame with additional steel frame Floor: Concrete Walls: Stone</p> <p>This is only stone building on the site and one of the last to be constructed by the army, around 1957. It was an armoury for the storage of weapons and ammunition for the CMF.</p> <p>The building is in largely original condition. The original double steel door opening was narrowed in 1962.</p>	<p>Building: High significance</p> <p>Overall external building form: High significance Overall building interior: High significance Roof cladding: Moderate significance Original timber gables: High significance Original stone walls: High significance Original concrete floor: Moderate significance</p> <p>Recommendation: The Armoury is an unusual army building and should be conserved and maintained to retain cultural significance.</p>

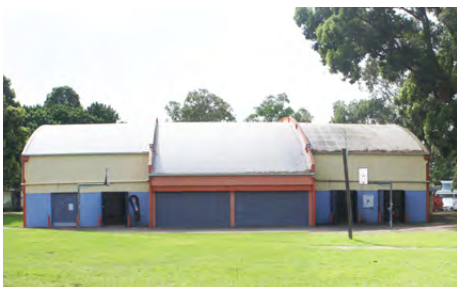
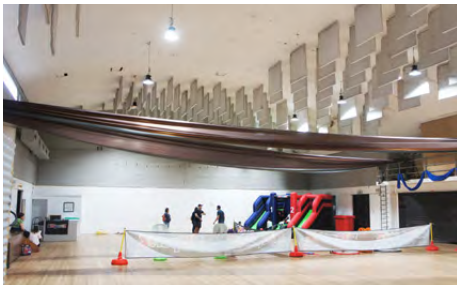
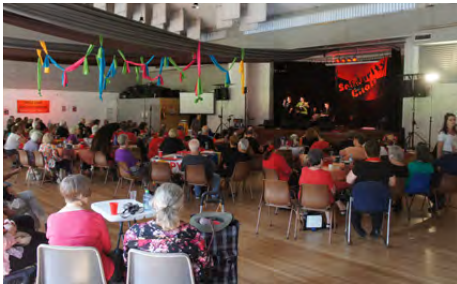
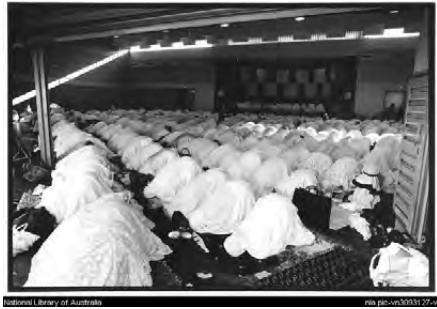
<p>Figure 3.67 - Indonesian Muslim women at prayer, end of Ramadan, in Gumbramorra Hall, 19 January 1999 Source: Photo By John Immig, National Library of Australia, [nla.pic.yn3093127-v]</p>	<p>Gumbramorra Hall 1988-1990</p> <p>Location: Centre of the site adjacent the large green open space.</p> <p>Characteristic and Condition:</p> <p>Overall condition: Fair to Poor</p> <p>Roof: Corrugated steel on steel frame Floor: Timber on concrete slab Walls: Brick & metal Ceilings: Various, suspended acoustic and plasterboard</p> <p>Gumbramorra Hall is the largest, most significant intervention on the site in the post army period. Financed by a Federal government Bicentennial Grant in 1988, the hall was designed by the NSW Government Architect.</p> <p>Since its construction the hall has hosted many community and multi-cultural events.</p> <p>The hall is a large building and has fundamentally breached the integrity of the open space of the former army parade ground by blocking views across the site and by effectively dividing it into two separate spaces.</p> <p>The external form of the building is arguably of mediocre architectural quality.</p> <p>The external envelope of the building is poorly detailed. We understand there are flooding issues arising from the building's location and drainage and roof design.</p>	<p>Building: Moderate significance</p> <p>Overall external building form: Low significance Overall building interior: Low significance</p> <p>Recommendation: Gumbramorra Hall has moderate social significance arising from its long-standing function as the site of many significant community events. However its size and location in the middle of the former parade ground detracts from the cultural significance of the overall site, by blocking and subdividing what was traditionally a single central open space. In this sense it may be considered to be intrusive.</p> <p>The building can be maintained as a hall without further compromising the significance of the open space of the site. There should be no increase in its current footprint or bulk.</p> <p>The hall could be demolished without reducing the cultural significance of the overall site.</p>

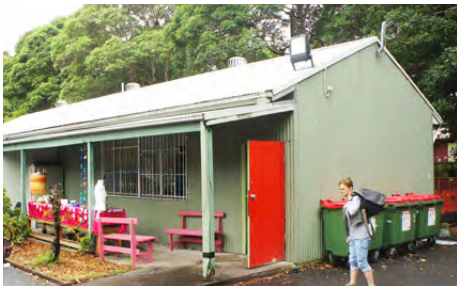
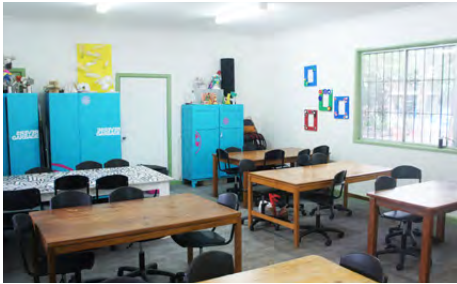
Building No.	Photograph	Description and Condition	Significance Rating and Recommendation
5

<p>Figure 3.71 - Interior</p> <p>Photos: Phillips Marler 2017</p>	<p>YWCA / Reverse Garbage c. 1992-2002</p> <p>Location: To the east of the site between Vivi Koutsounadis Drive and the main car park.</p> <p>Characteristic and Condition:</p> <p>Overall Condition: Fair</p> <p>The building stands at the eastern end of the former army parade ground, an area that was generally kept clear of buildings during the army era, with the exception of the early 1940s when small sleeping huts were temporarily placed there.</p>	<p>Building: Little significance</p> <p>Recommendation: Removal of this building at an appropriate time in the future is recommended as it detracts from the cultural significance of the open space of the former parade ground.</p>

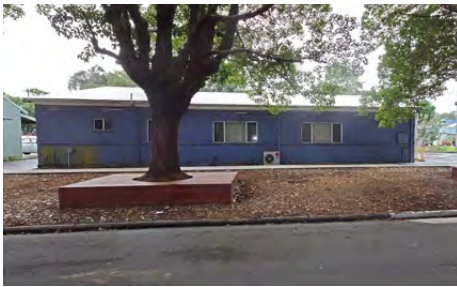
Building No.	Photograph	Description and Condition	Significance Rating and Recommendation
6

<p>Figure 3.73 - Western elevation (main entry)</p> <p>Photos: Phillips Marler 2017</p>	<p>Settlement Services International c. 1992-2002</p> <p>Location: To the east of the site between Vivi Koutsounadis Drive and the main car park.</p> <p>Characteristic and Condition:</p> <p>Overall Condition: Fair</p> <p>The building stands at the eastern end of the former army parade ground, an area that was generally kept clear of buildings during the army era, with the exception of the early 1940s when small sleeping huts were temporarily placed there.</p>	<p>Building: Little significance</p> <p>Recommendation: Removal of this building at an appropriate time in the future is recommended as it detracts from the cultural significance of the open space of the former parade ground.</p>

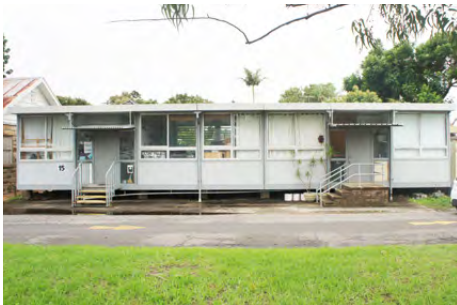
Building No.	Photograph	Description and Condition	Significance Rating and Recommendation
15

<p>Figure 3.74 - Eastern elevation</p>	<p>“Demountable” c. 1980s Ultimo Art Project</p> <p>Location: Northern edge of the site next to the Armoury (Fair Trade Emporium).</p> <p>Characteristic and Condition:</p> <p>Overall Condition: Fair</p>	<p>Building: Little significance</p> <p>Recommendation: The building can be maintained, repaired or demolished without affecting the cultural significance of the overall site.</p>

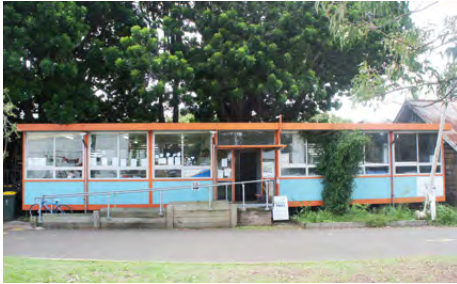
Building No.	Photograph	Description and Condition	Significance Rating and Recommendation
16

<p>Figure 3.75 - Eastern elevation</p> <p>Photos: Phillips Marler 2017</p>	<p>“Demountable” c. 1980s Half Moon Yoga/ Autism Spectrum</p> <p>Location: Northern edge of the site opposite the Gumbramorra Hall.</p> <p>Characteristic and Condition:</p> <p>Overall Condition: Fair</p>	<p>Building: Little Significance</p> <p>Recommendation: The building can be maintained, repaired or demolished without affecting the cultural significance of the overall site.</p>

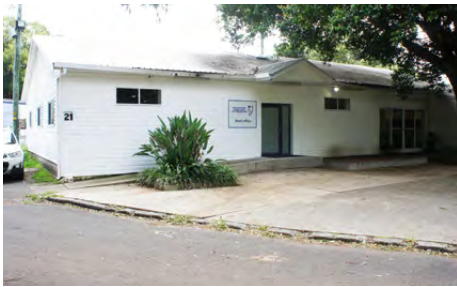
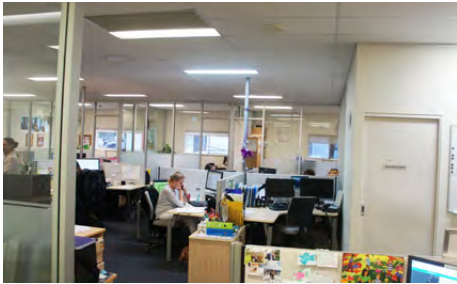
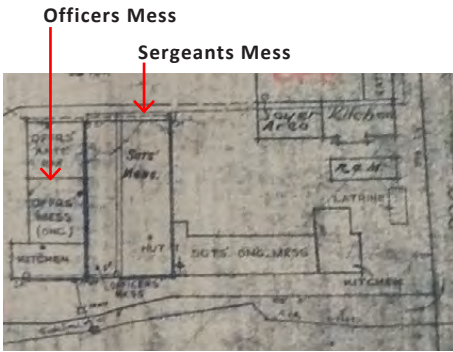
Building No.	Photograph	Description and Condition	Significance Rating and Recommendation
21

<p>Officers Mess Sergeants Mess</p> <p>Figure 3.77a - Detail from Marrickville Military Depot Block Plan 1941, Sergeants Mess and Officers Mess.</p> <p>Source: National Archives of Australia, ST3294/1ST3294/1/0456/7/746</p>	<p>Community Child Care Co-Op</p> <p>Location: South east corner of the site.</p> <p>Characteristic and Condition:</p> <p>Overall Condition: Fair</p> <p>The building stands on the site of the former Sergeants Mess and Officers Mess building c. 1940, which burnt down (refer Fig. 3.77a)</p>	<p>Building: Little significance</p> <p>Recommendation: The building can be maintained, repaired or demolished without affecting the cultural significance of the overall site.</p>

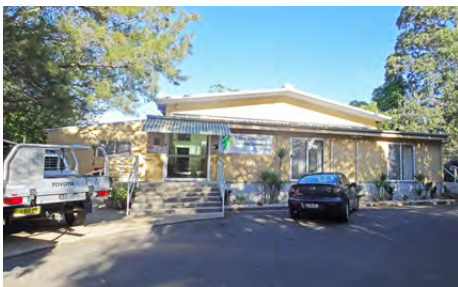
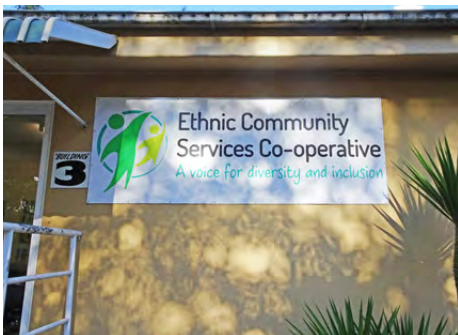
Building No.	Photograph	Description and Condition	Significance Rating and Recommendation
3

<p>Figure 3.79 - Main Entry Sign</p>	<p>Ethnic Community Services Co-operative</p> <p>Location: Along the southern boundary of the site between the Community Nursery and the Addison Road Child Care Centre.</p> <p>Characteristic and Condition:</p> <p>Overall Condition: Fair</p> <p>The building stands partially over the site of one of the former WWI Gun Parks.</p>	<p>Building: Little Significance</p> <p>Recommendation:</p> <p>The building can be maintained, repaired or demolished without affecting the cultural significance of the overall site. The building should not be extended beyond the set-back line formed by the northern face of the former Gun Parks.</p> <p>Should the building be demolished and replaced with a new building, the later could duplicate the footprint of the former Gun Park.</p>

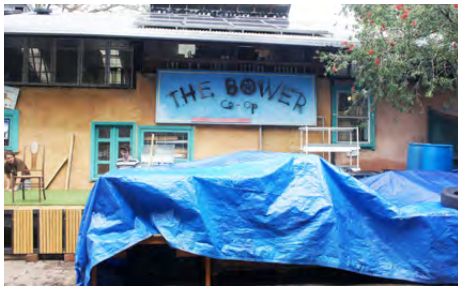
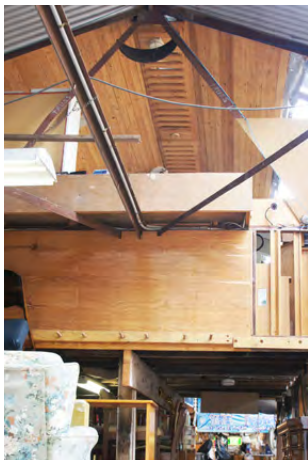
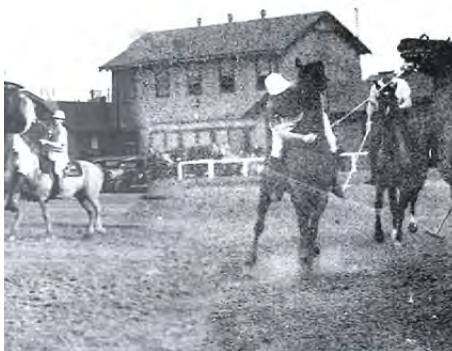
Building No.	Photograph	Description and Condition	Significance Rating and Recommendation
34

<p>Figure 3.81a - Detail from 1934 photo by Sam Hood showing the former Australian Field Army office. Source: One Small World by Sue Castrique 2017, Collection of the State Library NSW.</p>	<p>The Bower</p> <p>Location: Southern edge of the site next to the ARCCO main office.</p> <p>Characteristic and Condition:</p> <p>Overall Condition: Fair</p> <p>The building stands on the site of the former two storey Australian Field Artillery office which burnt down in 1976 (refer Fig. 3.81a).</p> <p>This building has been associated with the re-cycling and sustainable use of materials.</p>	<p>Building: Little Significance</p> <p>Recommendation: The building can be maintained, repaired or demolished without affecting the cultural significance of the overall site. The building should not be extended beyond the set-back line formed by the northern face of the former Gun Parks.</p> <p>Should the building be demolished and replaced with a new building, the later should duplicate the approximate footprint and possibly the two storey height of the former AFA office.</p>

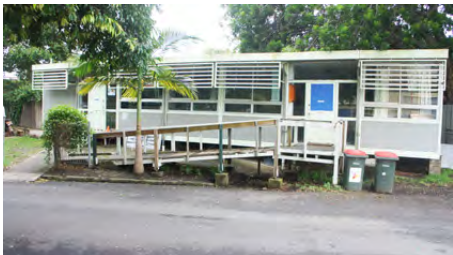
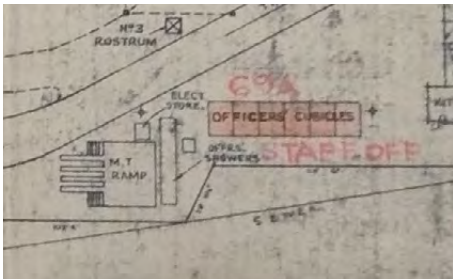
Building No.	Photograph	Description and Condition	Significance Rating and Recommendation
47

<p>Figure 3.82A - Detail from Marrickville Military Depot Block Plan 1941 showing 'MT Ramp' Source: National Archives of Australia, ST3294/1ST3294/1/0456/7/746</p>	<p>"Demountable" c. 1980s Casa Latina / Autism Spectrum</p> <p>Location: Northern edge of the site opposite the Gumbramorra Hall</p> <p>Characteristic and Condition:</p> <p>Overall Condition: Fair</p> <p>The building stands on the site of the former Motor Transport Ramp c.1940, which enabled two trucks at a time to be driven up a ramp onto an elevated platform for inspection, maintenance and repair (refer Fig. 3.82A).</p>	<p>Building: Little significance</p> <p>Recommendation: This portable building can be maintained, repaired, demolished or removed without affecting the cultural significance of the overall site.</p>

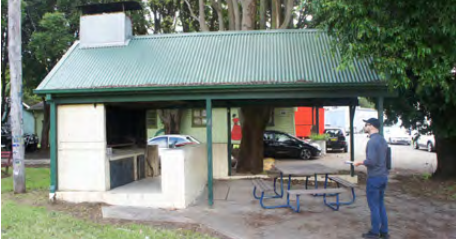
<p data-bbox="231 573 528 600">Figure 3.83 - Eastern elevation</p> <p data-bbox="225 1877 496 1897">Photos: Phillips Marler 2017</p>	<p data-bbox="710 324 1018 351">Picnic Shelter and Barbecue</p> <p data-bbox="710 387 1042 477">Location: Western side of the large open green space</p> <p data-bbox="710 512 1031 539">Characteristic and Condition:</p> <p data-bbox="710 575 956 602">Overall Condition: Fair</p>	<p data-bbox="1117 324 1417 351">Building: Little significance</p> <p data-bbox="1117 387 1485 539">Recommendation: This structure can be maintained, repaired or demolished without affecting the cultural significance of the overall site.</p>

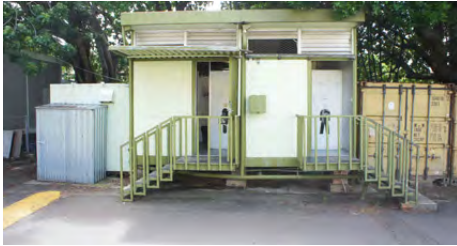
<p data-bbox="229 568 528 595">Figure 3.84 - Eastern elevation</p> <p data-bbox="225 1877 501 1897">Photos: Phillips Marler 2017</p>	<p data-bbox="708 318 983 376">“Demountable” c. 1980s Toilets</p> <p data-bbox="708 414 1042 506">Location: Western side of the large open green space</p> <p data-bbox="708 539 1031 566">Characteristic and Condition:</p> <p data-bbox="708 602 956 629">Overall Condition: Fair</p>	<p data-bbox="1117 318 1417 344">Building: Little significance</p> <p data-bbox="1117 380 1485 566">Recommendation: This portable building can be maintained, repaired, demolished or removed without affecting the cultural significance of the overall site.</p>

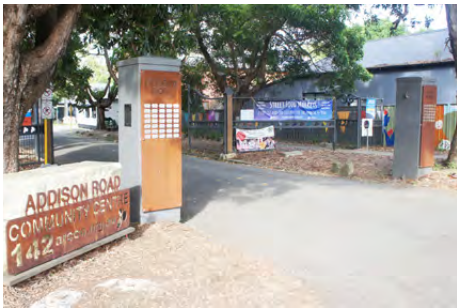
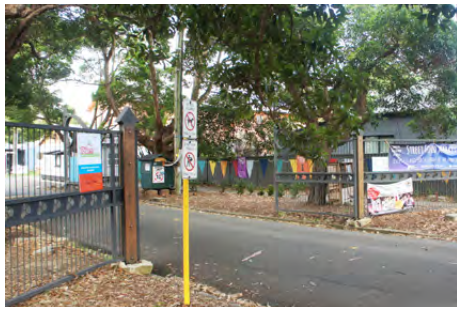
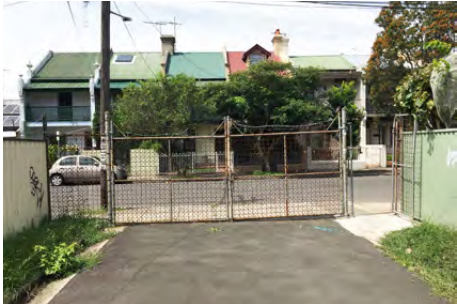
Item No.	Photograph	Description and Condition	Significance Rating and Recommendation
1

<p>Figure 3.2.4 - Pedestrian entry and exit gates to Illawarra Road</p>	<p>Main Vehicle and Pedestrian Entry</p> <p>Location: Addison Road</p> <p>Characteristic and Condition: Two plinths with Honour Roll made of weathered steel flank the main entrance driveway and face Addison Road. There is an 'Addison Road Community Centre' naming sign made of weathered steel fixed to a sculpted sandstone block. The elements are in good condition. Two vehicle and two pedestrian entry gates are made of steel with laser cut patterning. The gate posts are made of timber and steel and are in good condition. Painted artwork murals adorn the Colorbond boundary fences to the entry driveway.</p> <p>Date: 2015</p> <p>Pedestrian Entry</p> <p>Location: Illawarra Road</p> <p>Characteristic and Condition: Pedestrian entry gate and vehicle entry gates approximately two metres high and made of steel mesh which has become weathered. Barbed wire runs along the top of the gates. There is no entry signage.</p> <p>Date: unknown</p>	<p>High significance</p> <p>The Entry via Addison Road has been the main entry since the army period and should be retained as the main entry to the ARCC. The entry plinths should be retained as original fabric.</p> <p>Recommendation: Retain the entry in this location. Consider whether gates could be relocated and installed closer to the plinths to restore the entry to its army era alignment.</p> <p>Moderate significance</p> <p>Recommendation: The pedestrian entry in this location is a secondary entry dating from the original army period and should be retained. The fence and gate have no heritage significance and can be replaced if required.</p>

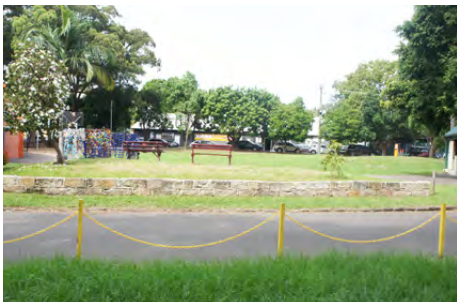
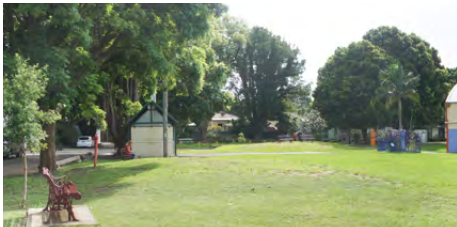
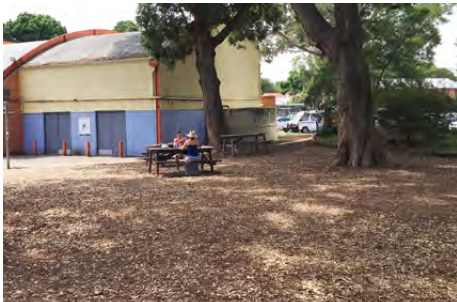
Item No.	Photograph	Description and Condition	Significance Rating and Recommendation
3

<p>Figure 3.2.11 - View east to the mulched picnic setting area</p>	<p>Large Green Open Space and Picnic Area</p> <p>Location: Centre of the site to the western end</p> <p>Characteristic and Condition: Large grassed open space (approximately 100m²) is edged by mature tree plantings to the south and west and the Gumbramorra Hall to the east. A low stone block wall retains levels along the northern edge. A concrete footpath crosses from north to south.</p> <p>There are a number of fixed elements and amenities including sculpture, fixed seating, a small low stage and a brick picnic shelter with oven.</p> <p>The picnic area has a three timber picnic settings and an organic mulch surface. Large mature Eucalypts provide shade.</p> <p>The site of tennis courts visible in the 1961 aerial shot (Fig. 2.74)</p> <p>Date: The entire area became open space following the burning of the original Hut 47 'Casa Latina' visible in Figs. 2.77 and 2.78.</p>	<p>High Significance</p> <p>Recommendation: The large open space is highly valued for its park like qualities and opportunities for passive recreation and temporary events.</p> <p>The open space should be retained and no permanent buildings considered for this space.</p> <p>Replacement of park furniture and the installation of sculptures either permanent or temporary is acceptable. The installation of any items should consider scale, form and the impact to views across the site.</p> <p>The mulched area is large and planting beds and ground covers could be considered to enhance the open space setting if required. Additional park furniture is acceptable.</p>

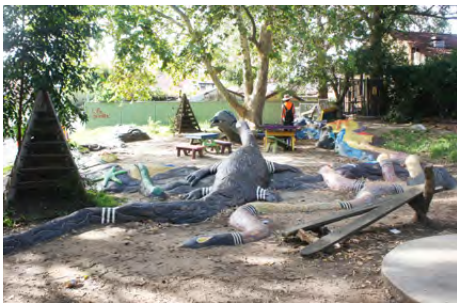
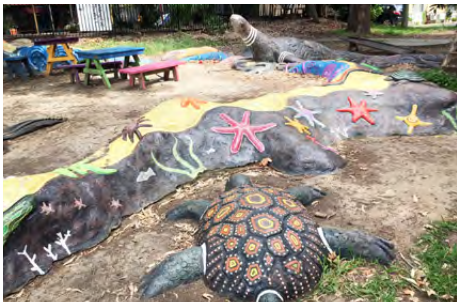
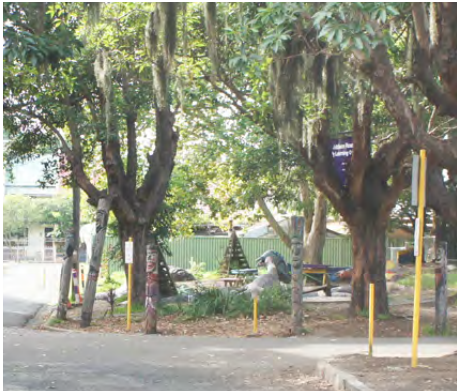
Item No.	Photograph	Description and Condition	Significance Rating and Recommendation
5

<p>Figure 3.2.16 - Totem pole artworks positioned at the edge of the playground</p>	<p>Playground</p> <p>Location: South eastern corner of the site in front of Building 4 (Addison Road Child Care Centre).</p> <p>Characteristic and Condition: The playground contains a number of low level bespoke elements including colourful rendered play sculptures and freestanding artworks that provide balancing and imagination play experiences. The playground has no standard manufactured playground equipment, structures or safety surfacing. There are a number of small colourful, moveable seats and tables. Shade is provided by mature London Plane and Queensland Brush Box trees.</p> <p>Date: 1970s.</p>	<p>Moderate Significance</p> <p>The sculptural play elements were created by an artist (tba) and have recently been repainted. The sculptures are for public enjoyment and part of the artistic expression of ARCCO and should be maintained and protected to retain cultural significance.</p>

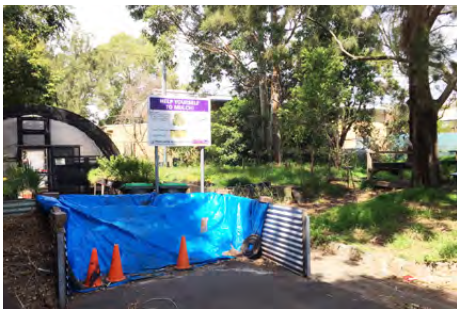
Item No.	Photograph	Description and Condition	Significance Rating and Recommendation
6

<p>Figure 3.2.18 - Community Nursery trees</p>	<p>Community Nursery</p> <p>Location: Along the southern edge of the site next to ARCCO Main Office building.</p> <p>Characteristic and Condition: A number of small buildings and external work benches facilitate the propagation and growing of native plants. An organic mulch bay is constructed of timber and corrugated metal. There are a number of mature native trees providing shade.</p> <p>Date: 1990s-2000s</p>	<p>Little heritage significance</p> <p>The community nursery occupies the site of Purdy's Farm, former Gun Parks and a former section of the circulation road around the site.</p> <p>The nursery is a compatible use but the site could be considered for additional buildings on the former footprints of the Gun Parks and restoring the missing section of the site circulation road could also be considered to enhance cultural significance.</p>

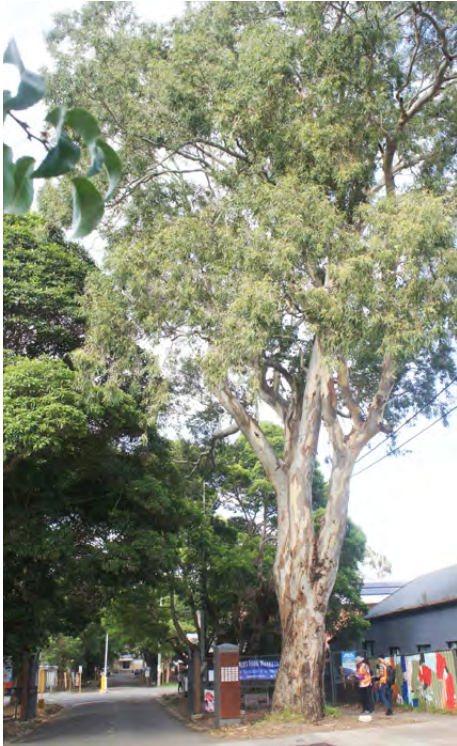
Tree / Group Number	Photograph	Description and Condition	Significance Rating and Comment/Recommendation
T1

<p>Figure 3.2.28 - Large River Red Gum at the main entrance on Addison Road</p>	<p><i>Eucalyptus camaldulensis</i> River Red Gum (1 tree)</p> <p>Location: Western side of the main entrance to Addison Road.</p> <p>Characteristic and Condition: Approximately 25 metres in height and canopy spread. The tree is noted as being in good health.</p> <p>Date: c. 1920s</p>	<p>High Significance</p> <p>This tree dates from the pre -1930s and is a substantial specimen in good health.</p> <p>As a landmark tree at the entry to the ARCC and in the Addison Road landscape, the tree should be protected and maintained to retain cultural significance.</p> <p>It is one of the largest trees of its kind in the Marrickville area.</p>
