Addison Road Community Centre

Conservation Management Plan

prepared for

27th July 2018

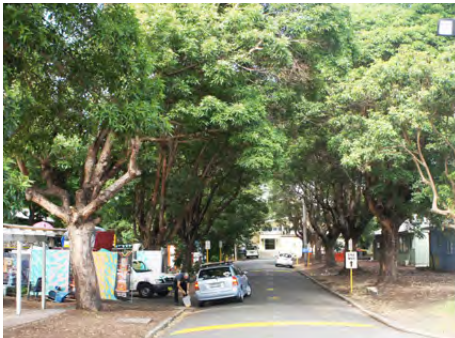
Tree / Group Number	Photograph	Description and Condition	Significance Rating and Comment/Recommendation
T2	  <p>Figure 3.2.29 - Queensland Brush Box trees at the main entrance on Addison Road</p>

<p>Figure 3.2.30 - Queensland Brush Box avenue along Vivi Koutsounadis Drive</p>	<p><i>Lophostemon confertus</i> Queensland Brush Box (23 trees)</p> <p>Location: Along Vivi Koutsounadis Drive from the main entrance on Addison Road to the Ethnic Child Care Centre.</p> <p>Characteristic and Condition: An avenue of trees approximately 10-15 metres in height and canopy spread. Generally in good health however a number suffer from root damage due to compacted soils.</p> <p>Date: c. 1920s</p>	<p>High Significance</p> <p>The avenue of brushboxes on Vivi Koutsounadis Drive is an intact avenue of trees marking the entrance to the ARCC and dating from the pre-1930s army period. The avenue creates a ceremonial character to the arrival to ARCC.</p> <p>The trees should be protected from all impacts both temporary and permanent and maintained to retain cultural significance.</p>

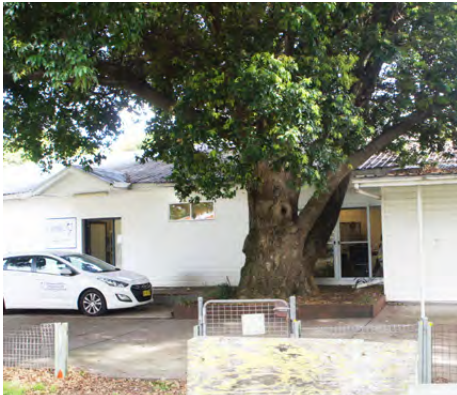
Tree Number	Photograph	Description and Condition	Significance Rating and Recommendation
T4

<p>Figure 3.2.32 - Weeping Lilly Pilly at the entrance of Building 21</p>	<p><i>Syzygium floribundum</i> Weeping Lilly Pilly (1 tree)</p> <p>Location: Raised timber edged garden bed adjacent to the entrance of Building 21 (Community Child Care Co-op).</p> <p>Characteristic and Condition: Large mature tree in good health and stands around 15-20 metres in height with a broad canopy spread of 30 metres. The tree is noted as being an outstanding example of the species.</p> <p>Date: c. 1930s</p>	<p>High Significance</p> <p>Tree dates from the 1930s-1945 Army Period. The tree should be protected and maintained to retain cultural significance.</p>
T5

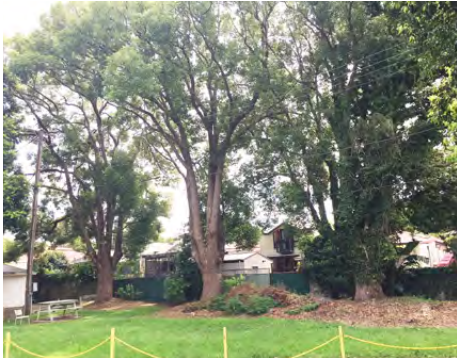
<p>Figure 3.2.33 - Camphor Laurel trees located along the northern boundary fence</p>

<p>Figure 3.2.34 - Soil grade changes around one tree</p>	<p><i>Cinnamomum camphora</i> Camphor Laurel (3 trees)</p> <p>Location: Close to the northern property boundary (to the rear of the grassed area between Buildings 21 and 47).</p> <p>Characteristic and Condition: Large trees are almost 30 metres in height and canopy spread. Two of the trees are in good health and one tree (located furthest from Building 21) is in poor health (noted to be likely as a consequence of soil grade changes).</p> <p>Date: c. 1930s</p>	<p>High Significance</p> <p>The three trees date from the pre-1943 army period. The trees are significant boundary plantings and should be retained and protected. If failure occurs a suitable species of similar habit and form should be considered to retain cultural significance.</p>

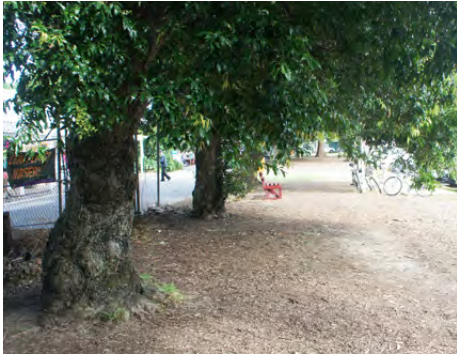
Tree / Group Number	Photograph	Description and Condition	Significance Rating and Comment/Recommendation
T6

<p>Figure 3.2.35 - Four Weeping Lilly Pilly trees along the fence line to the Community Nursery</p>	<p><i>Syzygium floribundum</i> Weeping Lilly Pilly (4 trees)</p> <p>Location: A line of four Weeping Lilly Pilly trees are planted adjacent to the Community Nursery fence line.</p> <p>Characteristic and Condition: This line of trees are 10-15 metres in height and canopy spread. The trees are all in good health.</p> <p>Date: c. late 1950s to 1961</p>	<p>High Significance</p> <p>The trees are part of a significant single avenue of Weeping Lilly Pilly planted during the pre-1950 army period.</p> <p>The avenue should be protected and retained to maintain cultural significance.</p>

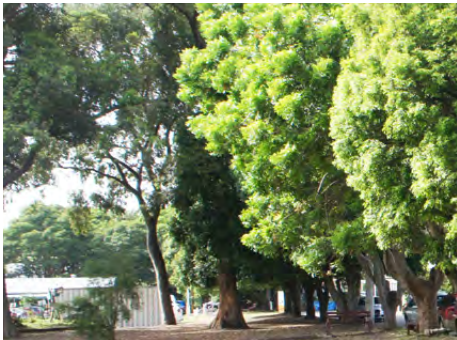
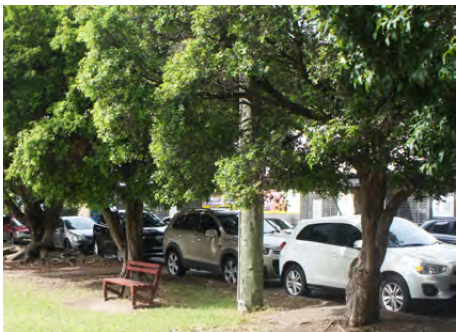
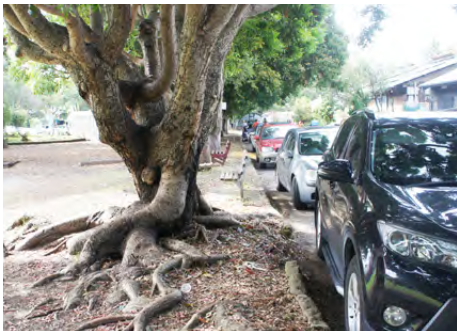
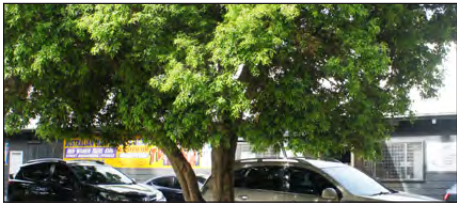
Tree / Group Number	Photograph	Description and Condition	Significance Rating and Comment/Recommendation
T7

<p>Figure 3.2.36 - Weeping Lilly Pilly (5 trees) on the southern edge of the green space</p>

<p>Figure 3.2.37 - Crow's Ash (3 trees)</p>

<p>Figure 3.2.38 - Exposed roots of the Kaffir Plum tree</p>

<p>Figure 3.2.39 - Two Lily Pilly trees</p>	<p><i>Syzygium floribundum</i> Weeping Lilly Pilly (5 trees)</p> <p><i>Flindersia australis</i> Crow's Ash (3 trees)</p> <p><i>Harpephyllum caffrum</i> Kaffir Plum (1 tree)</p> <p><i>Syzygium smithii</i> Lilly Pilly (2 trees)</p> <p>Location: A row of eleven native and exotic trees along the southern edge of the large open green space.</p> <p>Characteristic and Condition: The Weeping Lily Pilly, Crow's Ash and Kaffir Plum trees are approximately 10-15 metres in height and are in good health. The Kaffir Plum has exposed roots and is suffering from root damage. The Lily Pilly trees (5-10 metres in height and spread) are noted as being in good to fair health.</p> <p>Date: c. 1940s</p>	<p>High Significance</p> <p>The trees are part of a significant single avenue of large canopy trees of diverse species that date from the pre-1950's period and delineate the southern boundary of the parade ground.</p> <p>The avenue should be protected and maintained to retain cultural significance.</p>

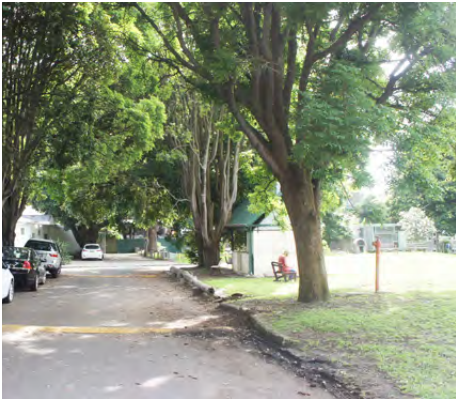
Tree / Group Number	Photograph	Description and Condition	Significance Rating and Comment/Recommendation
T8	  <p>Figure 3.2.40 - Weeping Lilly Pilly (1 tree)</p>

<p>Figure 3.2.41 - Crow's Ash (3 trees) along the western edge of the green space</p>	<p><i>Syzygium floribundum</i> Weeping Lilly Pilly (5 trees)</p> <p><i>Flindersia australis</i> Crow's Ash (3 trees)</p> <p>Location: Along the western edge of the green space.</p> <p>Characteristic and Condition: The Weeping Lilly Pilly is 10-15 metres in height and canopy spread and is noted as being in good health. The Crow's Ash are between 15-20 metres in height with a canopy spread 10-15 metres. These trees form an avenue along the access road and are in fair to good health, however soil compaction is an issue.</p> <p>Date: c. 1940s The 1950 aerial photograph shows the trees at the edge of the former parade ground turned vehicle park.</p>	<p>High Significance</p> <p>The trees are part of a significant mixed avenue of trees visible on the 1950s aerial.</p> <p>The avenue should be protected and retained to maintain cultural significance.</p>

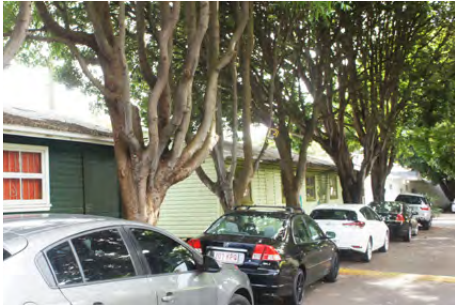
Tree / Group Number	Photograph	Description and Condition	Significance Rating and Comment/Recommendation
T9

<p>Figure 3.2.42 - Crow's Ash trees along the western edge of the green space</p>

<p>Figure 3.2.43 - Cars park on tree roots next to buildings 44 and 45.</p>	<p><i>Flindersia australis</i> Crow's Ash (3 trees)</p> <p>Location: Along the western edge of the access road adjacent to Buildings 44 (Bush Music Club) and 45 (Kid A Performing Arts Co.).</p> <p>Characteristic and Condition: The trees are between 15-20 metres in height with a canopy spread 10-15 metres forming an avenue along the access road. The trees are noted as being in good health. Vehicles are currently parking on tree roots resulting in compaction and root damage.</p> <p>Date: c. 1940s</p>	<p>High Significance</p> <p>The trees are part of a significant avenue of large canopy trees of diverse species that date from the pre-1950 period.</p> <p>The avenue should be protected and maintained to retain cultural significance.</p>

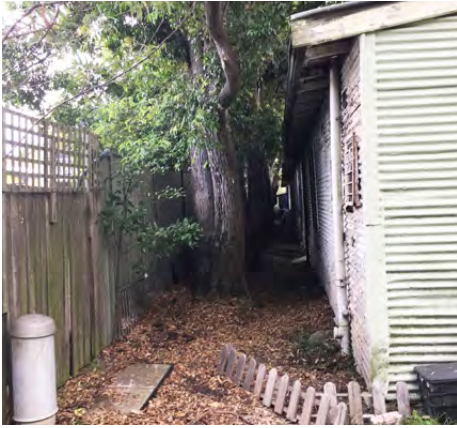
Tree / Group Number	Photograph	Description and Condition	Significance Rating and Comment/Recommendation
T10

<p>Figure 3.2.44 - Row of Lilly Pilly trees along the boundary</p>

<p>Figure 3.2.45 - Camphor Laurel tree between building 24 and the boundary fence</p>	<p><i>Syzigium floribundum</i> Weeping Lilly Pilly (8 trees) <i>Cinnamomum camphora</i> Camphor Laurel (1 tree)</p> <p>Location: Along the western property boundary (behind buildings 24 and 24A).</p> <p>Characteristic and Condition: Nine mature trees approximately 15-20 metres in height with a canopy spread of 10-15 metres. The trees are noted as being in good health with one tree in fair health and one tree in poor health. All trees suffer from poor pruning. The Camphor Laurel tree at the northern of the row is also 15-20 metres in height with a canopy spread of 10-15 metres. This tree is in fair health however the root system is exposed and has become restricted by the building.</p> <p>Date: c. 1940s</p>	<p>Moderate Significance</p> <p>This grouping dates from the pre-1950s period and are mature specimens. The trees are confined between the boundary and Drill Hall 2.</p> <p>The Camphor laurel has a significant canopy which has a strong presence on the boundary. However, the rootball of the Camphor laurel is pressing on the wall of this building and the tree may need to be removed to reduce the impact of the tree on the building. If removed the tree should not be replaced.</p> <p>The Weeping Lilly Pilly trees should be protected but the tree roots should be monitored to ensure there is no damage to the Drill Hall building.</p>

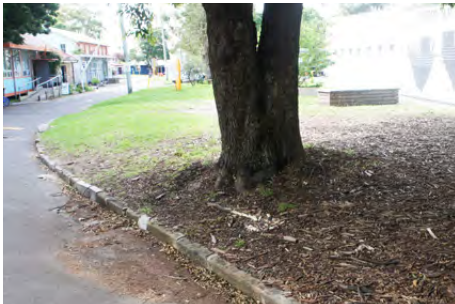
T13

<p>Figure 3.2.48 - Weeping Lily Pilly tree (possibly replace shot)</p>	<p><i>Syzygium floribundum</i> Weeping Lilly Pilly (2 trees)</p> <p>Location: Between Building 47 (Casa Latina) and The Gumbramorra Hall).</p> <p>Characteristic and Condition: Two mature trees have an average height and canopy spread of 15 metres and are in good health.</p> <p>Date: c.1950s</p>	<p>High Significance</p> <p>Visible on the 1961 aerial photography, these trees should be retained and protected to retain cultural significance.</p>

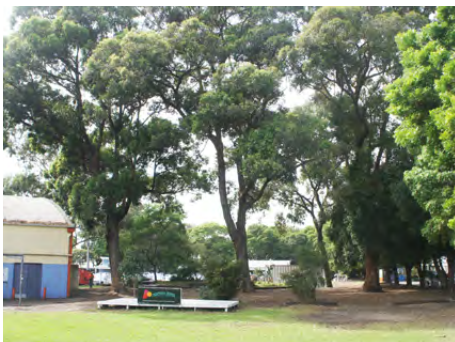
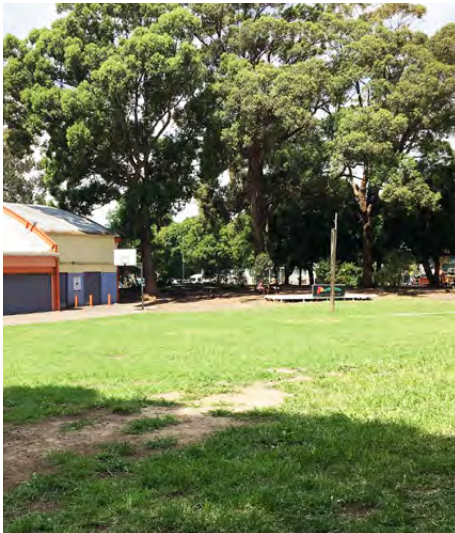
Tree / Group Number	Photograph	Description and Condition	Significance Rating and Comment/Recommendation
T14

<p>Figure 3.2.49 - Tallowood trees next to the Gumbramorra Hall</p>

<p>Figure 3.2.50 - Tallowood trees next to the Gumbramorra Hall</p>	<p><i>Eucalyptus microcorys</i> Tallowood (3 trees)</p> <p>Location: Planted in a row between the car park and the large open green space next to the Gumbramorra Hall.</p> <p>Characteristic and Condition: The tall trees are between 20-30 metres in height and canopy spread and provide shade to the dedicated picnic setting area.</p> <p>Date: c.1950s to 1961</p>	<p>High significance</p> <p>These trees are visible on the 1961 aerial and are a remaining group of a significant avenue of trees on the northern edge of the parade ground. The trees should be protected and maintained to retain cultural significance.</p>
T15

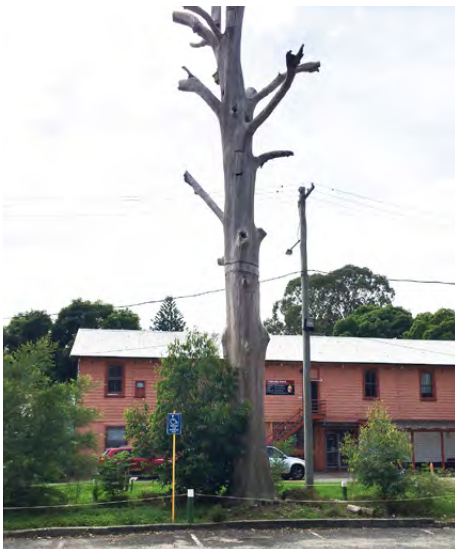
<p>Figure 3.2.51 - Dead Sydney Blue Gum tree has been retained for habitat creation</p>	<p><i>Eucalyptus Saligna</i> Sydney Blue Gum (Dead) "Urban Habitat Tree"</p> <p>Location: Northern edge of the car park (opposite Building 13).</p> <p>Characteristic and Condition: The dead tree trunk (15 metres tall) 'The Urban Habitat Tree' was created from a Sydney Blue Gum that required removal due to safety concerns. Rather than removing the tree, steps were taken to remove branches and make the tree safe. The tree is being monitored as a habitat for local birds and microbats, which are recorded and monitored by the local community.</p>	<p>Moderate Significance</p> <p>The tree was planted in the 1980s-1990. It should be retained for its natural significance and for the role its in educating the community in the benefits of providing hollows for urban wildlife habitats.</p>

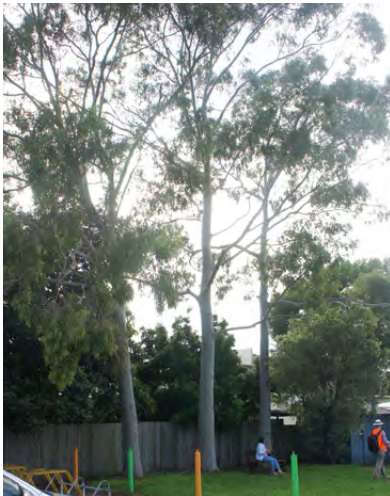
Tree / Group Number	Photograph	Description and Condition	Significance Rating and Recommendation
T16

<p>Figure 3.2.52 - Three Lemon-scented gum trees against the boundary</p>	<p><i>Corymbia citriodora</i> Lemon-scented gum (1 tree)</p> <p>Location: Along the northern boundary near the toilet block next to Building 9b.</p> <p>Characteristic and Condition: Fair to good health and approximately 15 metres in height and spread.</p> <p>Date: c.1970s</p>	<p>Moderate Significance</p> <p>This group is visible on the 1986 aerial photograph and forms a strong presence on the boundary to ARCC .</p> <p>The open space next to the theatre includes the former footprint of an extension to the Depot Theatre.</p> <p>Should this footprint be used for an additional building the trees should be retained and protected to retain cultural significance.</p>
T17

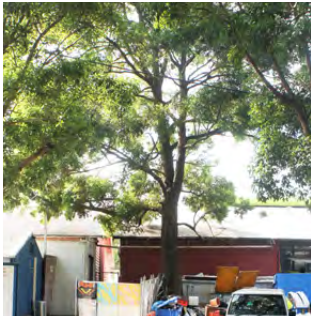
<p>Figure 3.2.53 - Tallowood tree in the front compound of Building 8 (Reverse Garbage)</p>

<p>Figure 3.2.55 - Red Iron Bark tree in the front compound of Building 8 (Reverse Garbage)</p>	<p><i>Eucalyptus micrcorys</i> Tallowood (1 tree) <i>Eucalyptus sideroxylon</i> Red Ironbark (1 tree) <i>Jacaranda mimosifolia</i> Jacaranda (1 tree)</p> <p>Location: Located in the front compound of Building 8 (Reverse Garbage).</p> <p>Characteristic and Condition: The Tallowood is a large mature specimen (15-20 metres in height and spread) and is in good health. The Red Ironbark is a semi mature tree approximately 15 metres in height and spread and is in good health. The Jacaranda (10-15 metres height and spread) is in good health however shows evidence of soil compaction and root damage. All trees have materials stored around their base.</p> <p>Date: c.1970s</p>	<p>Moderate Significance</p> <p>This group is visible on the 1986 aerial photograph. The trees should be maintained and protected.</p> <p>Storage of materials on the tree roots should be urgently removed to prevent further compaction and to remove clutter from the view to Building 8 beyond.</p>

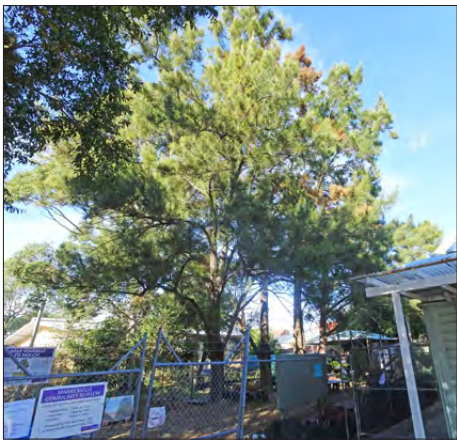
Tree / Group Number	Photograph	Description and Condition	Significance Rating and Recommendation
T19

<p>Figure 3.2.57 - Four River She-oaks in the Community Nursery site.</p>	<p><i>Casuarina Cunninghamiana</i> River She-oak (4 trees)</p> <p>Location: Planted in a row inside the Community Nursery site.</p> <p>Characteristic and Condition: The trees are 10-15 metres in height and spread and are noted as being in good health.</p> <p>Date: c.1970s</p>	<p>Moderate Significance</p> <p>The trees should be maintained and protected as they are a significant stand of trees contributing to the site's overall tree canopy.</p> <p>The site could also be considered for additional buildings on the footprint of the former Gun Parks which could require tree removal. Consideration should be given to tree replacement in association with any new building that might be considered for this site.</p>
T20

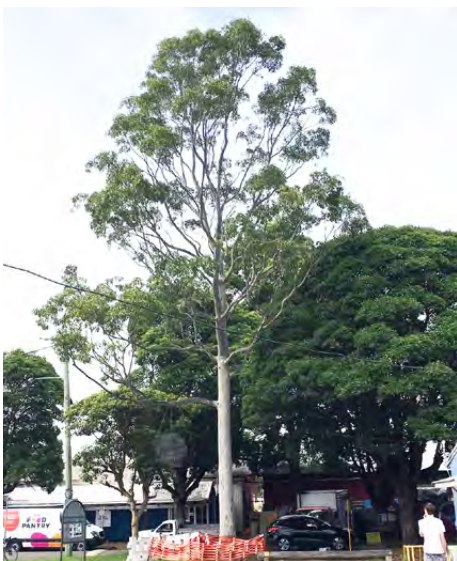
<p>Figure 3.2.58 - Mature Spotted Gum tree opposite Building 9a</p>	<p><i>Corymbia maculata</i> Spotted Gum (1 tree)</p> <p>Location: Opposite Building 9a near to the avenue of canopy trees along Vivi Koutsounadis Drive.</p> <p>Characteristic and Condition: The tall mature Spotted Gum is 20 metres in height and has a 15 metre canopy spread. The tree is in fair health.</p> <p>Date: c.1980s</p>	<p>High Significance</p> <p>This tree is a large specimen with a prominent location on the entry road to the ARCC.</p> <p>This tree contributes strongly to the aesthetic significance of the main entry precinct to ARCC should be maintained and protected to retain cultural significance.</p>

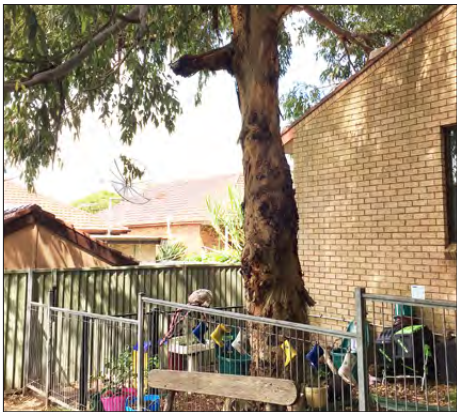
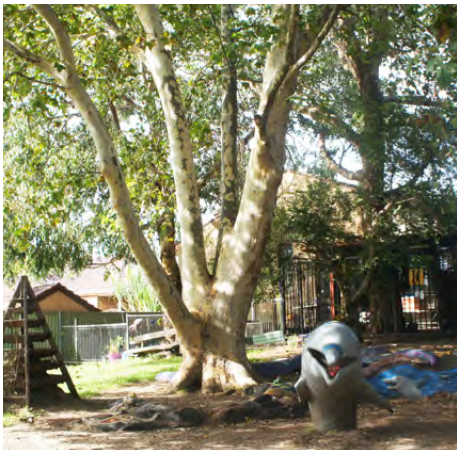
Tree / Group Number	Photograph	Description and Condition	Significance Rating and Recommendation
T22

<p>Figure 3.2.60 - Grey Gum tree inside the Child Care centre</p>

<p>Figure 3.2.61 - London Plane tree in the play-ground</p>	<p><i>Gleditsia triacanthos</i> Honey Locust (1 tree) <i>Syzygium floribundum</i> Weeping Lilly Pilly (1 tree) <i>Celtis australis</i> European Nettle Tree (1 tree) <i>Eucalypt sp.</i> Eucalypt (3 tree) <i>Eucalyptus punctata</i> Grey Gum (1 tree) <i>Cupaniopsis anacardiodes</i> Tuckaroo (1 tree) <i>Platanus x hybrida</i> London Plane (1 tree)</p> <p>Location: Within the fence and directly outside the Addison Road Child Care Centre.</p> <p>Characteristic and Condition: A mix of native and exotic mature and semi mature trees in good health, providing natural shade to the children's play areas.</p> <p>Date: c.1990</p>	<p>Moderate Significance</p> <p>This tree group should be maintained and protected to retain cultural significance.</p> <p>If the trees fail they could be considered for replacement by the same species or similar to maintain the overall tree canopy.</p>

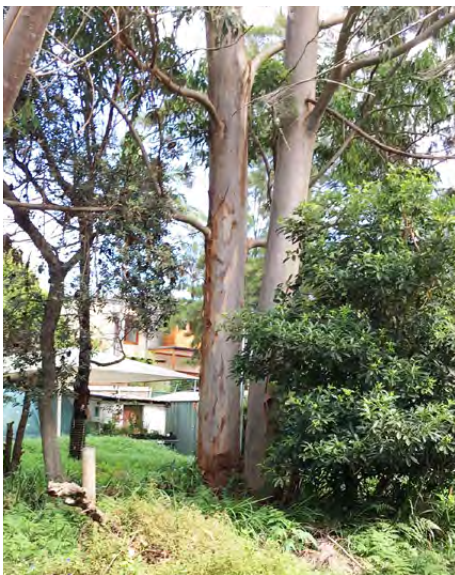
Tree / Group Number	Photograph	Description and Condition	Significance Rating and Recommendation
T23

<p>Figure 3.2.62 -</p>	<p><i>Eucalyptus saligna</i> Sydney Blue Gum (1 tree)</p> <p><i>Banksia integrifolia</i> Coast Banksia (2 trees)</p> <p><i>Brachychiton populneum</i> Kurrajong (1 tree)</p> <p><i>Melaluca linarifolia</i> Snow in Summer (1 tree)</p> <p>Location: A group of mature and semi-mature native trees in the Community Nursery site.</p> <p>Characteristic and Condition: The mature Sydney Blue Gum is 15-20 metres in height with a 15 metre canopy spread and is in good health. The semi-mature Coast Banksias (2 trees), Kurrajong (1 tree) and Melaluca (Snow in Summer) are in good to fair health.</p> <p>Date: c. mid 1990s</p>	<p>Moderate significance</p> <p>This tree group should be maintained and protected to retain cultural significance.</p> <p>If the trees fail they could be considered for replacement by the same species or similar to maintain the overall tree canopy.</p>

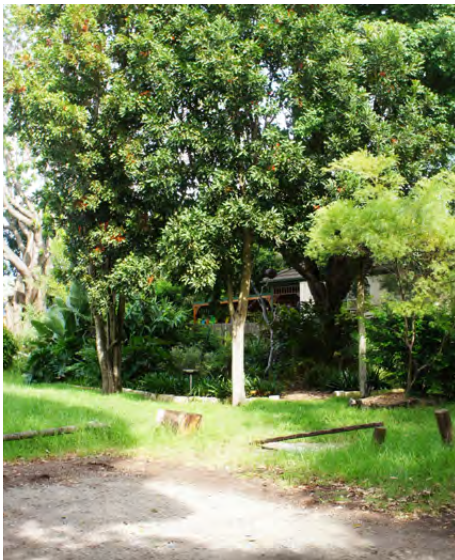
T27

<p>Figure 3.2.66 - A mixed group of native trees in the central 'nature reserve'</p>	<p><i>Stenocarpus sinuatus</i> Fire Wheel (1 tree)</p> <p>Location: A garden setting in the south western corner of the site (behind Building 38).</p> <p>Characteristic and Condition: The mature and semi mature trees are 10-15 metres in height with a canopy spread up to 10 metres. The trees are in good health.</p> <p>Date: c. 2000</p>	<p>Moderate Significance</p> <p>This tree group should be maintained and protected to retain cultural significance.</p> <p>If the trees fail they could be considered for replacement by the same species or similar in the same location to maintain the overall tree canopy.</p>

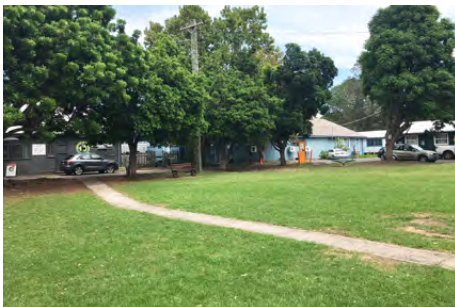
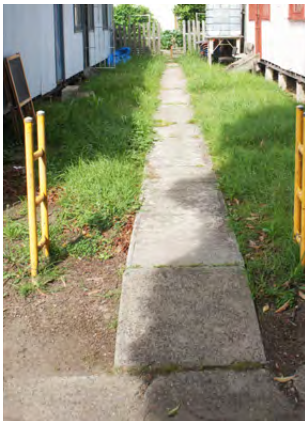
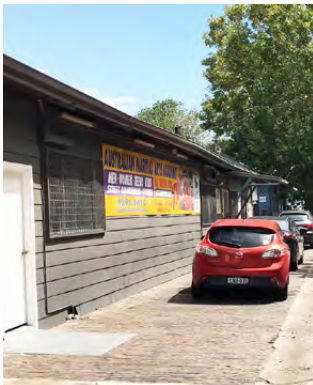
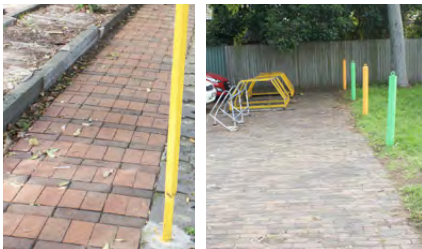
<p>Figure 3.2.69 - Concrete paths across the large open green space</p>

<p>Figure 3.2.70 - Concrete paths around buildings</p>

<p>Figure 3.2.71 - Brick paving next to Building 9b</p>

<p>Figure 3.2.72 - Brick paving along Vivi Koutsounadis Drive</p>	<p>Concrete paths</p> <p>Location:</p> <p>Concrete paths provide pedestrian access along the main entrance and at buildings at the eastern end (Toilet block and Addison Road Child Care Centre) and western end (through the large open green space and around buildings)</p> <p>Characteristic and Condition:</p> <p>Footpaths appear structurally sound with grass growing through some path joints.</p> <p>Date: Various</p> <p>Brick Paving on footpath</p> <p>Location:</p> <p>At the front of Buildings 35 and 36 and near the main entry toilet block.</p> <p>Characteristic and Condition:</p> <p>Brick paving outside the toilet block and Buildings 35 and 36 is laid in a stretcher bond pattern. The paving is in fair condition with a small number of broken bricks.</p> <p>Along Vivi Koutsounadis Drive (outside Building 8) a more recent brick paver has been laid with a darker brick header course.</p> <p>Date: post 2002</p>	<p>Little Significance</p> <p>The concrete path marks the alignment of the northern boundary of former tennis courts visible on the 1961 aerial (Fig. 2.74).</p> <p>However, with the tennis courts removed the path could be realigned or resurfaced if required without diminishing cultural significance</p> <p>Brick Paving outside Buildings 35 and 36</p> <p>Moderate Significance</p> <p>The footpath alongside this building alignment dates from the army-era and is significant and should be retained. Repairs should be considered if required.</p> <p>Brick paving outside Building 9b</p> <p>Little significance.</p> <p>Brick paving in this location is more recently laid and can be replaced if required.</p>
